Access Compliance Report

Public Rights-of-Way

(Curb Ramps)

Intersection ID: 11832	Main Street: DICKENS_AV	Cross Street: DUBLIN_RD	Location:	N
ADA ID: 1EDD6461422C	Ramp Type: Perp	Initial Pass/Fail: Fail	Overall Compliance: No	Severity Score: 10

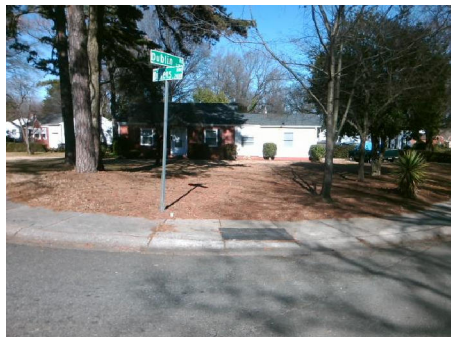
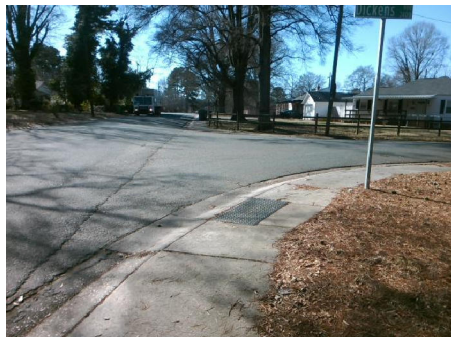
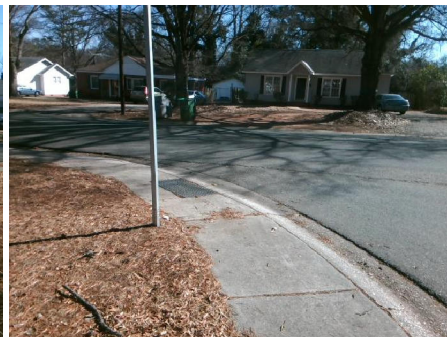
Not Found, R304.5.1, R304.5.3

Compliance	Description	Data	Compliance	Description	Data
N/A	Ramp Length (in)	47.0	Yes	Ramp Slope (%)	5.5
No	Ramp Width (in)	40.5	No	Ramp XSlope (%)	4.1
N/A	Flare Type LT	N/A	N/A	Flare Type RT	N/A
N/A	Flare Slope LT (%)	N/A	N/A	Flare Slope RT (%)	N/A
N/A	Flare Traversable LT?	N/A	N/A	Flare Traversable RT?	N/A
N/A	Landing Length (in)	N/A	N/A	DWS Provided?	N/A
N/A	Landing Width (in)	N/A	N/A	DWS Contrast?	N/A
N/A	Landing Slope (%)	N/A	N/A	DWS Length (in)	N/A
N/A	Landing X Slope (%)	N/A	N/A	DWS Full Width?	N/A
N/A	Landing Curb? (Y/N)	N/A	N/A	DWS Offset (in)	N/A
N/A	Shared Landing?	N/A			
N/A	Gutter Ponding?	N/A	N/A	Gutter Slope (%)	N/A
N/A	Gutter Lip Ht (in)	N/A	N/A	Gutter X Slope (%)	N/A
N/A	Painted X Walk1?	No	N/A	Painted X Walk2?	N/A
	X Walk 1 Direction	To SW		X Walk 2 Direction	N/A
N/A	X Walk 1 Width (in)	N/A	N/A	X Walk 2 Width (in)	N/A
	X Walk 1 Slope (%)	4.4		X Walk 2 Slope (%)	N/A
	X Walk 1 X Slope (%)	1.1		X Walk 2 X Slope (%)	N/A

N/A	Ramp inside XWalk1?	N/A	N/A	Ramp inside XWalk2?	N/A
	Road Slope (%)	N/A	N/A	Clear Space?	N/A
	Road X Slope (%)	N/A	N/A	Clear Space to XWalk (in)	N/A
N/A	Any Obstructions?	N/A	N/A	Storm Grate/Utility Hazard?	N/A
	Obstruction Type			Storm Grate/Utility Type	
		N/A			N/A
			Yes	Surface Condition? (G/P)	Good

Remove & Replace Entire Ramp.
