# Access Compliance Report

## Public Rights-of-Way

### (Curb Ramps)

Intersection ID: 16765	Main Street: CHURCHILL_RD	Cross Street: N_WENDOVER_RD	Location: SW
ADA ID: 1EE0075286C9	Ramp Type: PerpDiag	Initial Pass/Fail: Fail	Overall Compliance: No
		Severity Score: 22.5

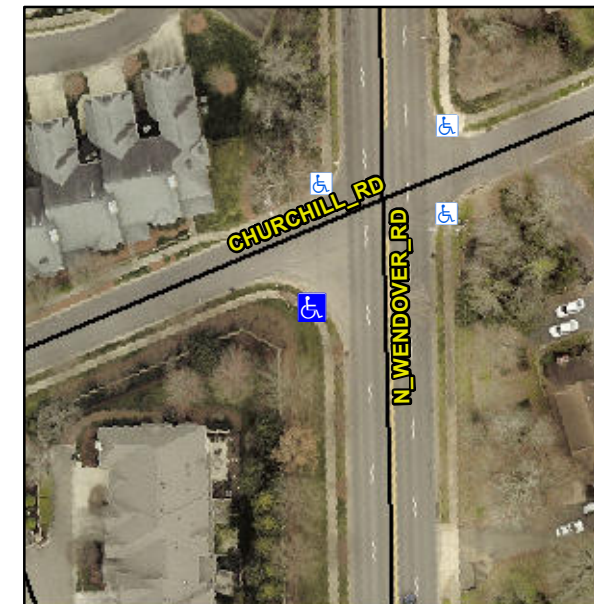
**Not Found, R304.5.1, R304.2.2, R304.5.3**

Compliance	Description	Data	Compliance	Description	Data
N/A	Ramp Length (in)	48.0	No	Ramp Slope (%)	11.8
No	Ramp Width (in)	45.5	No	Ramp XSlope (%)	3.6
N/A	Flare Type LT	N/A	N/A	Flare Type RT	N/A
N/A	Flare Slope LT (%)	N/A	N/A	Flare Slope RT (%)	N/A
N/A	Flare Traversable LT?	N/A	N/A	Flare Traversable RT?	N/A
N/A	Landing Length (in)	N/A	N/A	DWS Provided?	N/A
N/A	Landing Width (in)	N/A	N/A	DWS Contrast?	N/A
N/A	Landing Slope (%)	N/A	N/A	DWS Length (in)	N/A
N/A	Landing X Slope (%)	N/A	N/A	DWS Full Width?	N/A
N/A	Landing Curb? (Y/N)	N/A	N/A	DWS Offset (in)	N/A
N/A	Shared Landing?	N/A			
N/A	Gutter Ponding?	N/A	N/A	Gutter Slope (%)	N/A
N/A	Gutter Lip Ht (in)	N/A	N/A	Gutter X Slope (%)	N/A
N/A	Painted X Walk1?	No	N/A	Painted X Walk2?	No
	X Walk 1 Direction	To E		X Walk 2 Direction	To N
N/A	X Walk 1 Width (in)	N/A	N/A	X Walk 2 Width (in)	N/A
	X Walk 1 Slope (%)	3.9		X Walk 2 Slope (%)	2.2
	X Walk 1 X Slope (%)	1.8		X Walk 2 X Slope (%)	2.8

N/A	Ramp inside XWalk1?	N/A	N/A	Ramp inside XWalk2?	N/A
	Road Slope (%)	2.4	N/A	Clear Space?	N/A
	Road X Slope (%)	0.5	N/A	Clear Space to XWalk (in)	N/A
N/A	Any Obstructions?	N/A	N/A	Storm Grate/Utility Hazard?	N/A
	Obstruction Type			Storm Grate/Utility Type	
		N/A			N/A
			Yes	Surface Condition? (G/P)	Good

**Remove & Replace Curb Ramp With Two New Directional Ramps or Equivalent.**

Total Cost: \$ 3200.00
