# Access Compliance Report

## Public Rights-of-Way

### (Curb Ramps)

Intersection ID: 10015635	Main Street: HARRIS_CORNERS_PY	Cross Street: N/A	Location: S
ADA ID: 1EE48B410758	Ramp Type: Perp	Initial Pass/Fail: Fail	Overall Compliance: No
Severity Score: 12.5			
Codes/Mitigation Info/Possible Solution		Field Measurements/Component Compliance

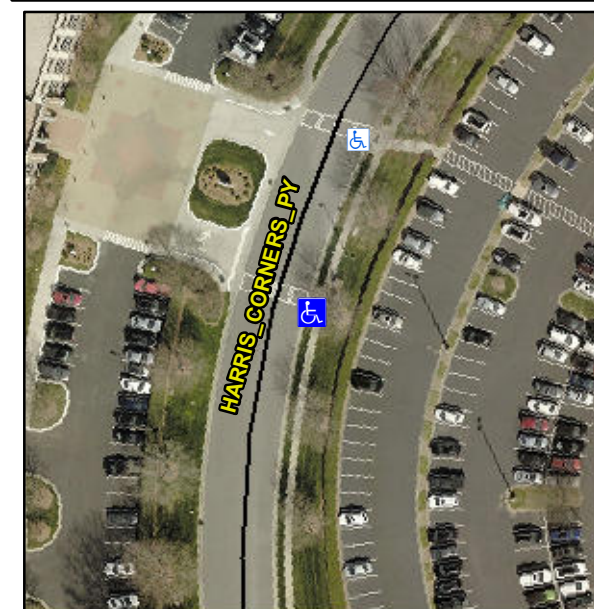
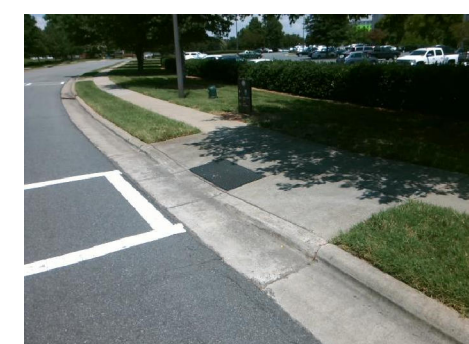
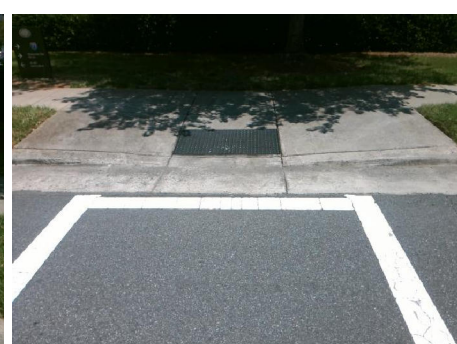
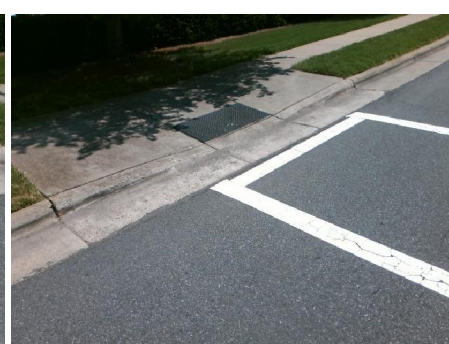
**Not Found, R304.2.2**

Compliance	Description	Data	Compliance	Description	Data
N/A	Ramp Length (in)	47.0	No	Ramp Slope (%)	9.1
Yes	Ramp Width (in)	48.0	Yes	Ramp XSlope (%)	0.9
N/A	Flare Type LT	N/A	N/A	Flare Type RT	N/A
N/A	Flare Slope LT (%)	N/A	N/A	Flare Slope RT (%)	N/A
N/A	Flare Traversable LT?	N/A	N/A	Flare Traversable RT?	N/A
N/A	Landing Length (in)	N/A	N/A	DWS Provided?	N/A
N/A	Landing Width (in)	N/A	N/A	DWS Contrast?	N/A
N/A	Landing Slope (%)	N/A	N/A	DWS Length (in)	N/A
N/A	Landing X Slope (%)	N/A	N/A	DWS Full Width?	N/A
N/A	Landing Curb? (Y/N)	N/A	N/A	DWS Offset (in)	N/A
N/A	Shared Landing?	N/A			
N/A	Gutter Ponding?	N/A	N/A	Gutter Slope (%)	N/A
N/A	Gutter Lip Ht (in)	N/A	N/A	Gutter X Slope (%)	N/A
N/A	Painted X Walk1?	Yes	N/A	Painted X Walk2?	N/A
	X Walk 1 Direction	To NW		X Walk 2 Direction	N/A
N/A	X Walk 1 Width (in)	87.5	N/A	X Walk 2 Width (in)	N/A
	X Walk 1 Slope (%)	1.2		X Walk 2 Slope (%)	N/A
	X Walk 1 X Slope (%)	0.3		X Walk 2 X Slope (%)	N/A

N/A	Ramp inside XWalk1?	Yes	N/A	Ramp inside XWalk2?	N/A
	Road Slope (%)	N/A	N/A	Clear Space?	N/A
	Road X Slope (%)	N/A	N/A	Clear Space to XWalk (in)	N/A
N/A	Any Obstructions?	N/A	N/A	Storm Grate/Utility Hazard?	N/A
	Obstruction Type			Storm Grate/Utility Type	
		N/A			N/A
		Yes		Surface Condition? (G/P)	Good

Possible Solutions:

**Remove & Replace Entire Ramp.**

Total Cost: \$ 1850.00
