Access Compliance Report

Public Rights-of-Way

(Curb Ramps)

Intersection ID: 52249	Main Street: PARK_RD	Cross Street: N/A	Location: NW
ADA ID: 1EE7C829614C	Ramp Type: Perp	Initial Pass/Fail: Fail	Overall Compliance: No
Severity Score: 13.75			
Codes/Mitigation Info/Possible Solution		Field Measurements/Component Compliance

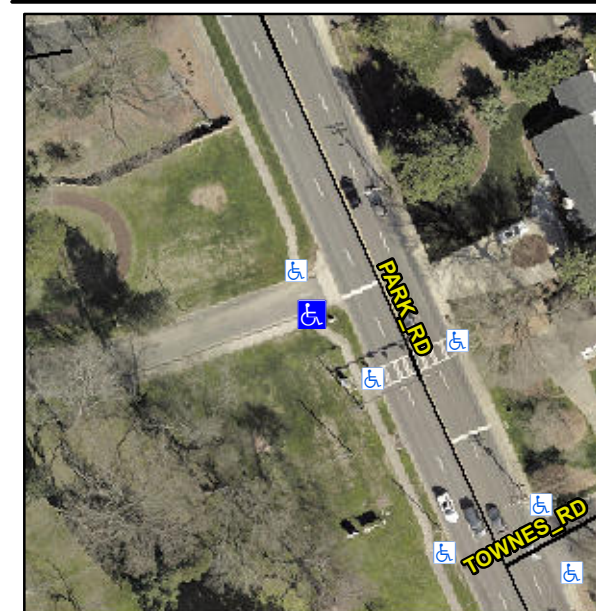
Not Found, R304.2.2, R304.5.3

Compliance	Description	Data	Compliance	Description	Data
N/A	Ramp Length (in)	79.0	No	Ramp Slope (%)	8.5
Yes	Ramp Width (in)	59.0	No	Ramp XSlope (%)	2.1
N/A	Flare Type LT	N/A	N/A	Flare Type RT	N/A
N/A	Flare Slope LT (%)	N/A	N/A	Flare Slope RT (%)	N/A
N/A	Flare Traversable LT?	N/A	N/A	Flare Traversable RT?	N/A
N/A	Landing Length (in)	N/A	N/A	DWS Provided?	N/A
N/A	Landing Width (in)	N/A	N/A	DWS Contrast?	N/A
N/A	Landing Slope (%)	N/A	N/A	DWS Length (in)	N/A
N/A	Landing X Slope (%)	N/A	N/A	DWS Full Width?	N/A
N/A	Landing Curb? (Y/N)	N/A	N/A	DWS Offset (in)	N/A
N/A	Shared Landing?	N/A			
N/A	Gutter Ponding?	N/A	N/A	Gutter Slope (%)	N/A
N/A	Gutter Lip Ht (in)	N/A	N/A	Gutter X Slope (%)	N/A
N/A	Painted X Walk1?	No	N/A	Painted X Walk2?	N/A
	X Walk 1 Direction	To NW		X Walk 2 Direction	N/A
N/A	X Walk 1 Width (in)	N/A	N/A	X Walk 2 Width (in)	N/A
	X Walk 1 Slope (%)	4.1		X Walk 2 Slope (%)	N/A
	X Walk 1 X Slope (%)	1.6		X Walk 2 X Slope (%)	N/A

N/A	Ramp inside XWalk1?	N/A	N/A	Ramp inside XWalk2?	N/A
	Road Slope (%)	N/A	N/A	Clear Space?	N/A
	Road X Slope (%)	N/A	N/A	Clear Space to XWalk (in)	N/A
N/A	Any Obstructions?	N/A	N/A	Storm Grate/Utility Hazard?	N/A
	Obstruction Type			Storm Grate/Utility Type	
		N/A			N/A
			Yes	Surface Condition? (G/P)	Good

Possible Solutions:

Remove & Replace Entire Ramp.
