Intersection ID: 14852	Main Street: HARRISBURG_RD	Cross Street: SHACKLEFORD_TR	Location:	SE
ADA ID: 1EF3A7EB90A7	Ramp Type: PerpDiag	Initial Pass/Fail: Fail	Overall Compliance: No	Severity Score: 50

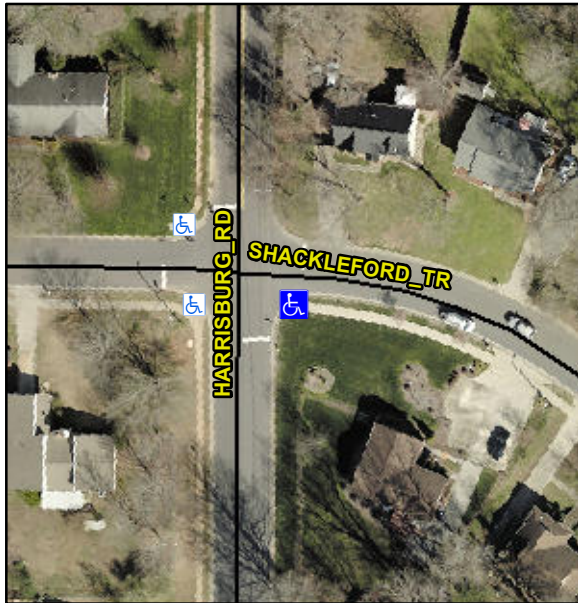
PROW/ADA:

R304.2.2, R304.5.3

Compliance	Description	Data	Compliance	Description	Data
N/A	Ramp Length (in)	48.0	No	Ramp Slope (%)	16.8
Yes	Ramp Width (in)	48.0	No	Ramp XSlope (%)	15.0
N/A	Flare Type LT	N/A	N/A	Flare Type RT	N/A
N/A	Flare Slope LT (%)	N/A	N/A	Flare Slope RT (%)	N/A
N/A	Flare Traversable LT?	N/A	N/A	Flare Traversable RT?	N/A
N/A	Landing Length (in)	N/A	N/A	DWS Provided?	N/A
N/A	Landing Width (in)	N/A	N/A	DWS Contrast?	N/A
N/A	Landing Slope (%)	N/A	N/A	DWS Length (in)	N/A
N/A	Landing X Slope (%)	N/A	N/A	DWS Full Width?	N/A
N/A	Landing Curb? (Y/N)	N/A	N/A	DWS Offset (in)	N/A
N/A	Shared Landing?	N/A			
N/A	Gutter Ponding?	N/A	N/A	Gutter Slope (%)	N/A
N/A	Gutter Lip Ht (in)	N/A	N/A	Gutter X Slope (%)	N/A
N/A	Painted X Walk1?	No	N/A	Painted X Walk2?	No
	X Walk 1 Direction	To N		X Walk 2 Direction	To W
N/A	X Walk 1 Width (in)	N/A	N/A	X Walk 2 Width (in)	N/A
	X Walk 1 Slope (%)	0.6		X Walk 2 Slope (%)	7.7
	X Walk 1 X Slope (%)	6.9		X Walk 2 X Slope (%)	0.5

N/A	Ramp inside XWalk1?	N/A	N/A	Ramp inside XWalk2?	N/A
	Road Slope (%)	6.3	N/A	Clear Space?	N/A
	Road X Slope (%)	6.4	N/A	Clear Space to XWalk (in)	N/A
N/A	Any Obstructions?	N/A	N/A	Storm Grate/Utility Hazard?	N/A
	Obstruction Type			Storm Grate/Utility Type	
		N/A			N/A
			Yes	Surface Condition? (G/P)	Good

Remove & Replace Curb Ramp With Two New Directional Ramps or Equivalent.
