Access Compliance Report

Public Rights-of-Way

(Curb Ramps)

Intersection ID: 5468	Main Street: N_TRYON_ST	Cross Street: J_W_CLAY_BV	Location: W
ADA ID: 1F07F18D23BF	Ramp Type: Perp	Initial Pass/Fail: Fail	Overall Compliance: No
Severity Score: 12.5			
Codes/Mitigation Info/Possible Solution		Field Measurements/Component Compliance

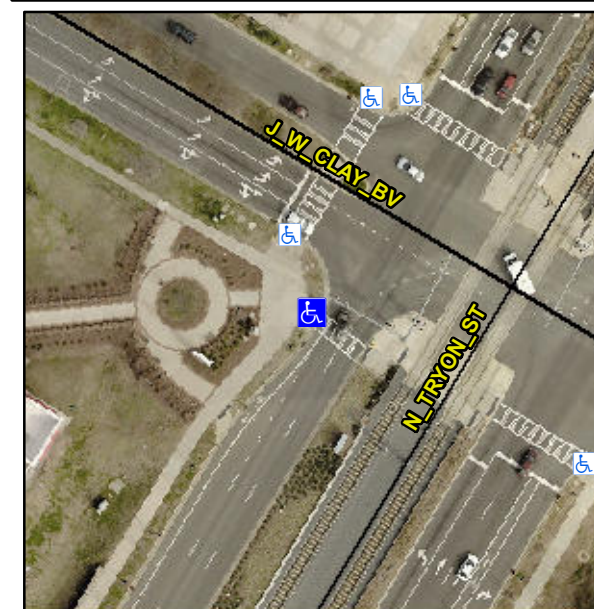
Compliance	Description	Data	Compliance	Description	Data
N/A	Ramp Length (in)	75.0	No	Ramp Slope (%)	8.7
Yes	Ramp Width (in)	48.0	Yes	Ramp XSlope (%)	0.9
N/A	Flare Type LT	N/A	N/A	Flare Type RT	N/A
N/A	Flare Slope LT (%)	N/A	N/A	Flare Slope RT (%)	N/A
N/A	Flare Traversable LT?	N/A	N/A	Flare Traversable RT?	N/A
N/A	Landing Length (in)	N/A	N/A	DWS Provided?	N/A
N/A	Landing Width (in)	N/A	N/A	DWS Contrast?	N/A
N/A	Landing Slope (%)	N/A	N/A	DWS Length (in)	N/A
N/A	Landing X Slope (%)	N/A	N/A	DWS Full Width?	N/A
N/A	Landing Curb? (Y/N)	N/A	N/A	DWS Offset (in)	N/A
N/A	Shared Landing?	N/A			
N/A	Gutter Ponding?	Yes	N/A	Gutter Slope (%)	N/A
N/A	Gutter Lip Ht (in)	N/A	N/A	Gutter X Slope (%)	N/A
N/A	Painted X Walk1?	No	N/A	Painted X Walk2?	N/A
	X Walk 1 Direction	To SE		X Walk 2 Direction	N/A
N/A	X Walk 1 Width (in)	N/A	N/A	X Walk 2 Width (in)	N/A
	X Walk 1 Slope (%)	2.3		X Walk 2 Slope (%)	N/A
	X Walk 1 X Slope (%)	0.9		X Walk 2 X Slope (%)	N/A

Possible Solutions:

Remove & Replace Entire Ramp.

PROW/ADA:

R304.2.2
