Access Compliance Report

Public Rights-of-Way

(Curb Ramps)

Intersection ID: 11898	Main Street: ALLEN_ST	Cross Street: E_18TH_ST	Location: S
ADA ID: 1F08C0F12081	Ramp Type: PerpDiag	Initial Pass/Fail: Fail	Overall Compliance: No
Severity Score: 1.25			
Codes/Mitigation Info/Possible Solution		Field Measurements/Component Compliance

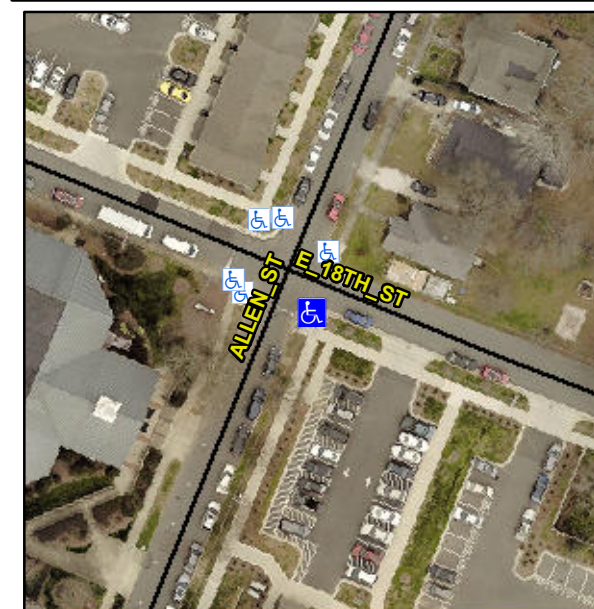
Compliance	Description	Data	Compliance	Description	Data
N/A	Ramp Length (in)	92.5	Yes	Ramp Slope (%)	8.2
Yes	Ramp Width (in)	50.5	No	Ramp XSlope (%)	2.8
N/A	Flare Type LT	N/A	N/A	Flare Type RT	N/A
N/A	Flare Slope LT (%)	N/A	N/A	Flare Slope RT (%)	N/A
N/A	Flare Traversable LT?	N/A	N/A	Flare Traversable RT?	N/A
N/A	Landing Length (in)	N/A	N/A	DWS Provided?	N/A
N/A	Landing Width (in)	N/A	N/A	DWS Contrast?	N/A
N/A	Landing Slope (%)	N/A	N/A	DWS Length (in)	N/A
N/A	Landing X Slope (%)	N/A	N/A	DWS Full Width?	N/A
N/A	Landing Curb? (Y/N)	N/A	N/A	DWS Offset (in)	N/A
N/A	Shared Landing?	N/A			
N/A	Gutter Ponding?	Yes	N/A	Gutter Slope (%)	N/A
N/A	Gutter Lip Ht (in)	N/A	N/A	Gutter X Slope (%)	N/A
N/A	Painted X Walk1?	No	N/A	Painted X Walk2?	No
	X Walk 1 Direction	To NE		X Walk 2 Direction	To NW
N/A	X Walk 1 Width (in)	N/A	N/A	X Walk 2 Width (in)	N/A
	X Walk 1 Slope (%)	1.5		X Walk 2 Slope (%)	1.7
	X Walk 1 X Slope (%)	3.4		X Walk 2 X Slope (%)	0.0

N/A	Ramp inside XWalk1?	N/A	N/A	Ramp inside XWalk2?	N/A
	Road Slope (%)	1.2	N/A	Clear Space?	N/A
	Road X Slope (%)	3.0	N/A	Clear Space to XWalk (in)	N/A
N/A	Any Obstructions?	N/A	N/A	Storm Grate/Utility Hazard?	N/A
	Obstruction Type			Storm Grate/Utility Type	
		N/A			N/A
		Yes		Surface Condition? (G/P)	Good

Possible Solutions:

Remove & Replace Curb Ramp With Two New Directional Ramps or Equivalent.

R304.5.3
