Access Compliance Report Public Rights-of-Way (Curb Ramps)

Intersection ID: 53534 Main Street: N_JOSH_BIRMINGHAM_PY Cross Street: WILKINSON_BV Location: NW **ADA ID: 1F0DCD959C68** Ramp Type: Perp Initial Pass/Fail: Fail **Overall Compliance: No Severity Score:** 12.5

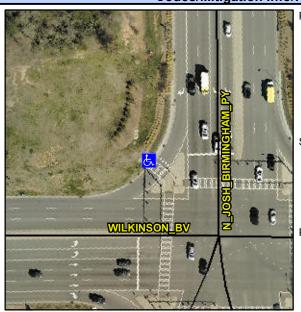
Field Measurements/Component Compliance						
Compliance Description		Data	Comp	liance	Description	Data
N/A	Ramp Length (in)	66.0	No	Ram	Slope (%)	9.1
Yes	Ramp Width (in)	48.0	Yes	Ram	XSlope (%)	0.2
N/A	Flare Type LT	N/A	N/A	Flare Type RT		N/A
N/A	Flare Slope LT (%)	N/A	N/A	Flare	Slope RT (%)	N/A
N/A	Flare Traversable LT?	N/A	N/A	Flare	Traversable RT?	N/A
N/A	Landing Length (in)	N/A	N/A	DWS	Provided?	N/A
N/A	Landing Width (in)	N/A	N/A	DWS	Contrast?	N/A
N/A	Landing Slope (%)	N/A	N/A	DWS	Length (in)	N/A
N/A	Landing X Slope (%)	N/A	N/A	DWS	Full Width?	N/A
N/A	Landing Curb? (Y/N)	N/A	N/A	DWS	Offset (in)	N/A
N/A	Shared Landing?	N/A				
N/A	Gutter Ponding?	N/A	N/A	Gutte	er Slope (%)	N/A
N/A	Gutter Lip Ht (in)	N/A	N/A	Gutte	er X Slope (%)	N/A
N/A	Painted X Walk1?	Yes	N/A	Paint	ed X Walk2?	N/A
	X Walk 1 Direction	To SE		X Wa	lk 2 Direction	N/A
N/A	X Walk 1 Width (in)	112.0	N/A	X Wa	lk 2 Width (in)	N/A
	X Walk 1 Slope (%)	3.5		X Wa	lk 2 Slope (%)	N/A

JOSH BIRMINGHAM PY Street 1 Name Stop Condition-Street 2 YieldSign Street 2 Name N/A Stop Condition-Street 1 N/A Possible Solutions: Remove & Replace Entire Ramp. Surveyor Notes: N/A PROW/ADA: Not Found, R304.2.2
