Access Compliance Report

Public Rights-of-Way

(Curb Ramps)

Intersection ID: N/A	Main Street: YORK_CENTER	Cross Street: N/A	Location: S
ADA ID: 1F10A9E3925A	Ramp Type: Perp	Initial Pass/Fail: Pass	Overall Compliance: No
Severity Score: 0			
Codes/Mitigation Info/Possible Solution		Field Measurements/Component Compliance

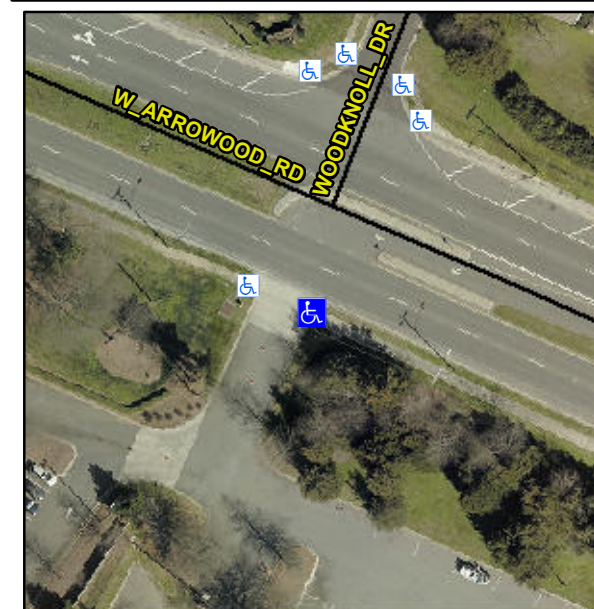
Compliance	Description	Data	Compliance	Description	Data
N/A	Ramp Length (in)	57.0	Yes	Ramp Slope (%)	5.6
Yes	Ramp Width (in)	72.0	Yes	Ramp XSlope (%)	1.0
N/A	Flare Type LT	Sloped	N/A	Flare Type RT	N/A
N/A	Flare Slope LT (%)	0.4	N/A	Flare Slope RT (%)	N/A
N/A	Flare Traversable LT?	No	N/A	Flare Traversable RT?	N/A
Yes	Landing Length (in)	77.0	Yes	DWS Provided?	Yes
Yes	Landing Width (in)	72.0	Yes	DWS Contrast?	Yes
No	Landing Slope (%)	4.3	Yes	DWS Length (in)	24.0
Yes	Landing X Slope (%)	0.0	Yes	DWS Full Width?	Yes
N/A	Landing Curb? (Y/N)	No	Yes	DWS Offset (in)	2.0
N/A	Shared Landing?	No			
Yes	Gutter Ponding?	No	Yes	Gutter Slope (%)	1.9
Yes	Gutter Lip Ht (in)	0.0	Yes	Gutter X Slope (%)	0.4
N/A	Painted X Walk1?	No	N/A	Painted X Walk2?	N/A
	X Walk 1 Direction	To NW		X Walk 2 Direction	N/A
N/A	X Walk 1 Width (in)	N/A	N/A	X Walk 2 Width (in)	N/A
	X Walk 1 Slope (%)	0.8		X Walk 2 Slope (%)	N/A
	X Walk 1 X Slope (%)	2.0		X Walk 2 X Slope (%)	N/A

N/A	Ramp inside XWalk1?	N/A	N/A	Ramp inside XWalk2?	N/A
	Road Slope (%)	N/A	N/A	Clear Space?	Yes
	Road X Slope (%)	N/A	N/A	Clear Space to XWalk (in)	N/A
Yes	Any Obstructions?	No	Yes	Storm Grate/Utility Hazard?	No
	Obstruction Type			Storm Grate/Utility Type	
		N/A			N/A
			Yes	Surface Condition? (G/P)	Good

Possible Solutions:

Remove & Replace Landing.

R304.2.2-Perp, R304.3.2-Para

Total Cost: \$ 500.00
