# Access Compliance Report

## Public Rights-of-Way

| Intersection ID: 16269 | Main Street: STERLING_RD | Cross Street: WELLESLEY_AV | Location: SW |
| ADA ID: 1F142CF98796 | Ramp Type: BlendTrans2 | Initial Pass/Fail: Fail | Overall Compliance: No |

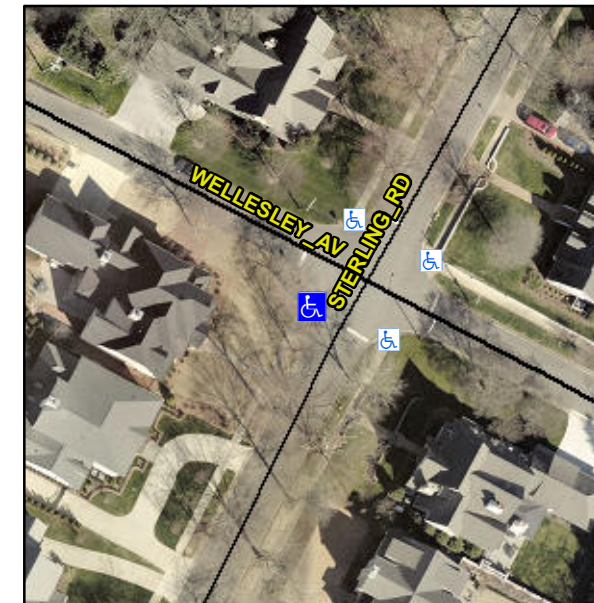
| Compliance | Description | Data | Compliance | Description | Data |
|---|---|---|---|---|---|
| No | Ramp Width (in) | 47.0 | No | BlendTrans XSlope (%) | 3.3 |

**Remove & Replace Curb Ramp With Two New Directional Ramps or Equivalent.**
