# Access Compliance Report

## Public Rights-of-Way

### (Curb Ramps)

Intersection ID: 10020989	Main Street: BERE_ISLAND_DR	Cross Street: N/A	Location: NE
ADA ID: 1F19681B6C75	Ramp Type: Perp	Initial Pass/Fail: Pass	Overall Compliance: No
		Severity Score: 0	
Codes/Mitigation Info/Possible Solution		Field Measurements/Component Compliance

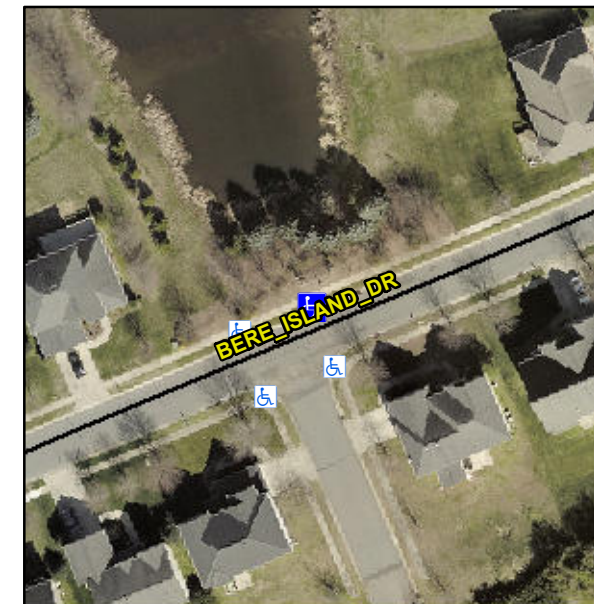
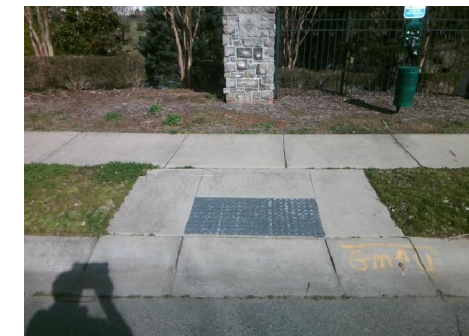
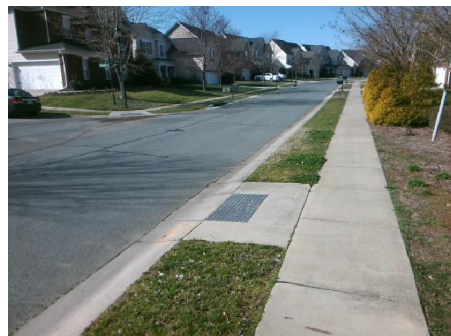
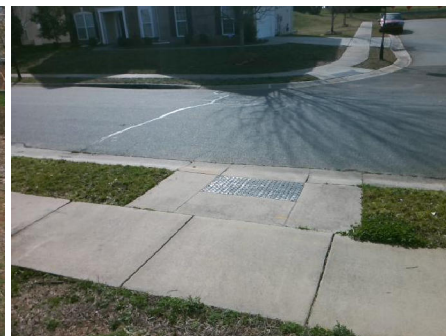
Compliance	Description	Data	Compliance	Description	Data
N/A	Ramp Length (in)	49.0	Yes	Ramp Slope (%)	5.7
Yes	Ramp Width (in)	48.0	Yes	Ramp XSlope (%)	0.8
N/A	Flare Type LT	Sloped	N/A	Flare Type RT	N/A
N/A	Flare Slope LT (%)	2.5	Yes	Flare Slope RT (%)	1.6
N/A	Flare Traversable LT?	Yes	N/A	Flare Traversable RT?	Yes
Yes	Landing Length (in)	48.0	Yes	DWS Provided?	Yes
Yes	Landing Width (in)	48.0	Yes	DWS Contrast?	Yes
Yes	Landing Slope (%)	1.6	Yes	DWS Length (in)	24.0
Yes	Landing X Slope (%)	0.9	Yes	DWS Full Width?	Yes
N/A	Landing Curb? (Y/N)	No	Yes	DWS Offset (in)	1.0
N/A	Shared Landing?	No			
Yes	Gutter Ponding?	No	Yes	Gutter Slope (%)	0.6
Yes	Gutter Lip Ht (in)	0.0	Yes	Gutter X Slope (%)	0.9
N/A	Painted X Walk1?	No	N/A	Painted X Walk2?	N/A
	X Walk 1 Direction	To SE		X Walk 2 Direction	N/A
N/A	X Walk 1 Width (in)	N/A	N/A	X Walk 2 Width (in)	N/A
	X Walk 1 Slope (%)	3.9		X Walk 2 Slope (%)	N/A
	X Walk 1 X Slope (%)	0.9		X Walk 2 X Slope (%)	N/A

N/A	Ramp inside XWalk1?	N/A	N/A	Ramp inside XWalk2?	N/A
	Road Slope (%)	N/A	N/A	Clear Space?	Yes
	Road X Slope (%)	N/A	N/A	Clear Space to XWalk (in)	N/A
Yes	Any Obstructions?	No	Yes	Storm Grate/Utility Hazard?	No
	Obstruction Type			Storm Grate/Utility Type	
		N/A			N/A
			Yes	Surface Condition? (G/P)	Good

**Remove & Replace Entire Ramp.**
