Access Compliance Report

Public Rights-of-Way

(Curb Ramps)

Intersection ID: 54455	Main Street: COLLINGHAM_DR	Cross Street: RUPELL_DR	Location: SW
ADA ID: 1F1C6CD45468	Ramp Type: BlendTrans1	Initial Pass/Fail: Fail	Overall Compliance: No
		Severity Score: 12.5

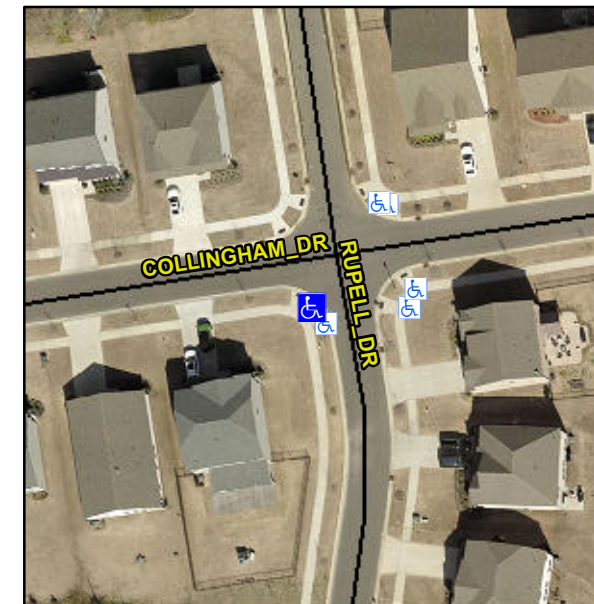
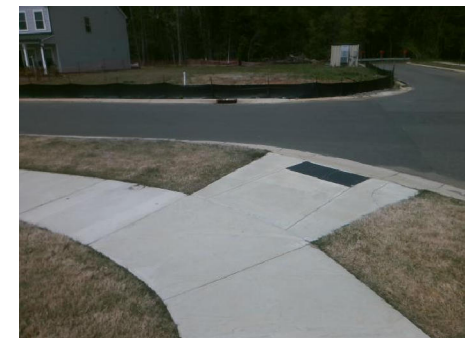
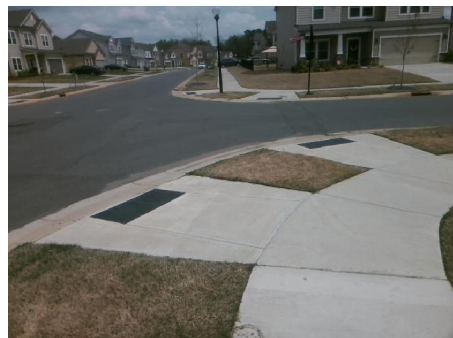
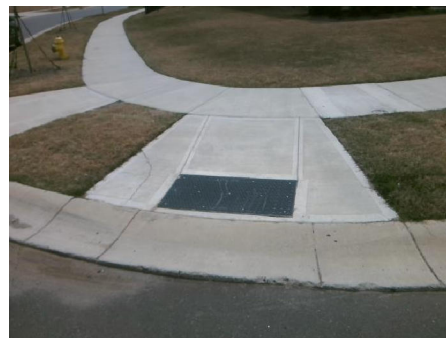
Not Found, R304.5.3

Compliance	Description	Data	Compliance	Description	Data
N/A	Ramp Length (in)	95.0	Yes	BlendTrans Slope (%)	0.2
Yes	Ramp Width (in)	48.0	No	BlendTrans XSlope (%)	5.2
N/A	Flare Type LT	N/A	N/A	Flare Type RT	N/A
N/A	Flare Slope LT (%)	N/A	N/A	Flare Slope RT (%)	N/A
N/A	Flare Traversable LT?	N/A	N/A	Flare Traversable RT?	N/A
N/A	Landing Length (in)	N/A	N/A	DWS Provided?	N/A
N/A	Landing Width (in)	N/A	N/A	DWS Contrast?	N/A
N/A	Landing Slope (%)	N/A	N/A	DWS Length (in)	N/A
N/A	Landing X Slope (%)	N/A	N/A	DWS Full Width?	N/A
N/A	Landing Curb? (Y/N)	N/A	N/A	DWS Offset (in)	N/A
N/A	Shared Landing?	N/A			
N/A	Gutter Ponding?	N/A	N/A	Gutter Slope (%)	N/A
N/A	Gutter Lip Ht (in)	1.5	N/A	Gutter X Slope (%)	N/A
N/A	Painted X Walk1?	No	N/A	Painted X Walk2?	N/A
	X Walk 1 Direction	To NW		X Walk 2 Direction	N/A
	X Walk 1 Width (in)	N/A		X Walk 2 Width (in)	N/A
	X Walk 1 Slope (%)	4.1		X Walk 2 Slope (%)	N/A
	X Walk 1 X Slope (%)	0.1		X Walk 2 X Slope (%)	N/A

N/A	Ramp inside XWalk1?	N/A	N/A	Ramp inside XWalk2?	N/A
	Road Slope (%)	0.1		Clear Space?	N/A
	Road X Slope (%)	4.1	N/A	Clear Space to XWalk (in)	N/A
N/A	Any Obstructions?	N/A	N/A	Storm Grate/Utility Hazard?	N/A
	Obstruction Type			Storm Grate/Utility Type	
		N/A			N/A
			Yes	Surface Condition? (G/P)	Good
			No	Curb Slope (%)	8.2

Remove & Replace Curb Ramp With Two New Directional Ramps or Equivalent.

Total Cost: \$ 3200.00
