# Access Compliance Report

## Public Rights-of-Way

### (Curb Ramps)

| Intersection ID: 30301 | Main Street: BLACK_KETTLE_DR | Cross Street: SHINKANSEN_DR | Location: S |

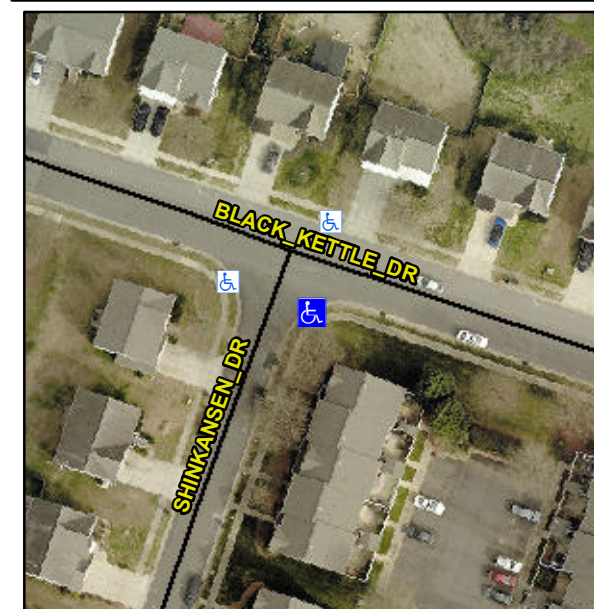
| ADA ID: 1F1D0B4F68C4 | Ramp Type: PerpDiag | Initial Pass/Fail: Fail | Overall Compliance: No |
| Severity Score: 8.75 | | | |

**Not Found, R304.5.1**

| Compliance | Description | Data | Compliance | Description | Data |
|---|---|---|---|---|---|
| N/A | Ramp Length (in) | 48.0 | Yes | Ramp Slope (%) | 7.7 |
| No | Ramp Width (in) | 40.5 | Yes | Ramp XSlope (%) | 0.8 |

**Remove & Replace Curb Ramp With Two New Directional Ramps or Equivalent.**

Total Cost: \$ 3200.00
