# Access Compliance Report

## Public Rights-of-Way

### (Curb Ramps)

| Intersection ID: 18337 | Main Street: SELWYN_AV | Cross Street: RUNNYMEDE_LN | Location: NE |

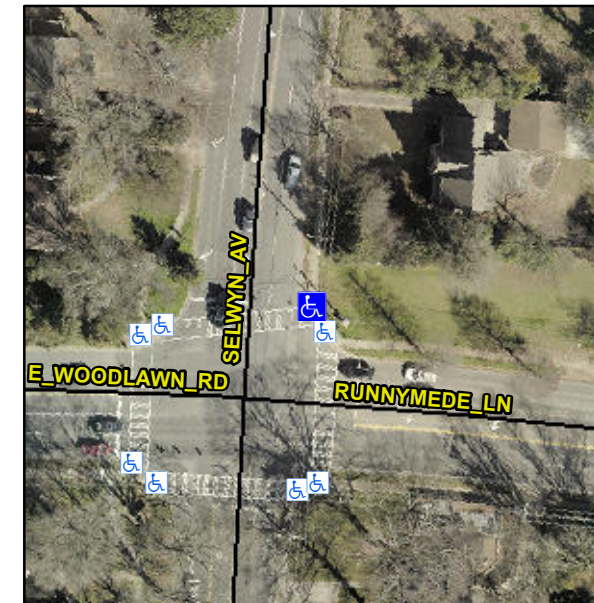
**Not Found, R304.5.1, R304.5.3**

| Compliance | Description | Data | Compliance | Description | Data |
|---|---|---|---|---|---|
| N/A | Ramp Length (in) | 48.0 | Yes | Ramp Slope (%) | 5.2 |
| No | Ramp Width (in) | 43.5 | No | Ramp XSlope (%) | 3.7 |

**Remove & Replace Entire Ramp.**

Total Cost: \$ 1850.00
