# Access Compliance Report

## Public Rights-of-Way

### (Curb Ramps)

Intersection ID: 27323	Main Street: MEADOW_RUN_LN	Cross Street: THORNHILL_CLUB_DR	Location: SE
ADA ID: 1F3DF33DC249	Ramp Type: BlendTrans1	Initial Pass/Fail: Fail	Overall Compliance: No
			Severity Score: 21.25

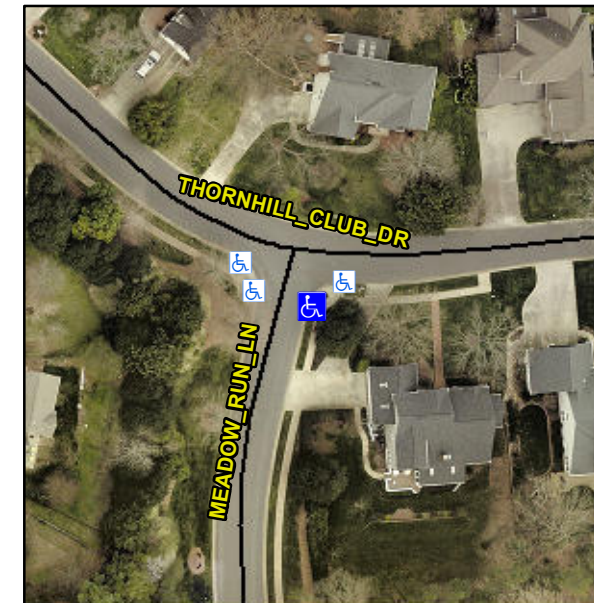
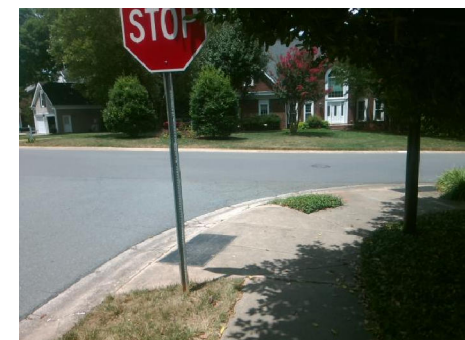
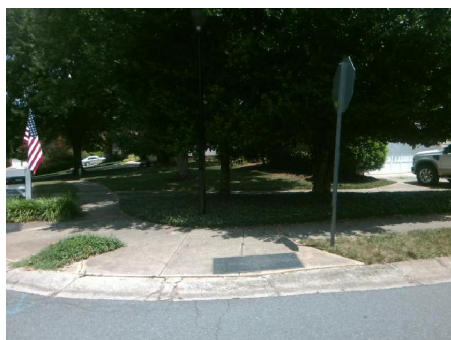
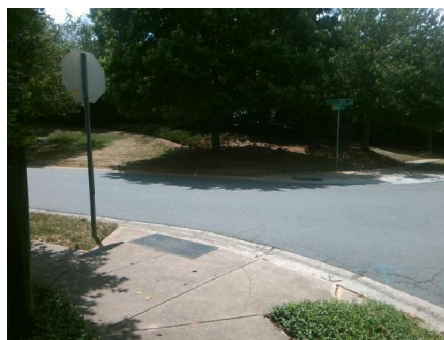
**Not Found, R304.5.1, R304.5.3**

Compliance	Description	Data	Compliance	Description	Data
N/A	Ramp Length (in)	94.0	Yes	BlendTrans Slope (%)	1.1
No	Ramp Width (in)	41.0	No	BlendTrans XSlope (%)	5.5
N/A	Flare Type LT	N/A	N/A	Flare Type RT	N/A
N/A	Flare Slope LT (%)	N/A	N/A	Flare Slope RT (%)	N/A
N/A	Flare Traversable LT?	N/A	N/A	Flare Traversable RT?	N/A
N/A	Landing Length (in)	N/A	N/A	DWS Provided?	N/A
N/A	Landing Width (in)	N/A	N/A	DWS Contrast?	N/A
N/A	Landing Slope (%)	N/A	N/A	DWS Length (in)	N/A
N/A	Landing X Slope (%)	N/A	N/A	DWS Full Width?	N/A
N/A	Landing Curb? (Y/N)	N/A	N/A	DWS Offset (in)	N/A
N/A	Shared Landing?	N/A			
N/A	Gutter Ponding?	N/A	N/A	Gutter Slope (%)	N/A
N/A	Gutter Lip Ht (in)	N/A	N/A	Gutter X Slope (%)	N/A
N/A	Painted X Walk1?	No	N/A	Painted X Walk2?	N/A
	X Walk 1 Direction	To W		X Walk 2 Direction	N/A
	X Walk 1 Width (in)	N/A		X Walk 2 Width (in)	N/A
	X Walk 1 Slope (%)	2.2		X Walk 2 Slope (%)	N/A
	X Walk 1 X Slope (%)	3.2		X Walk 2 X Slope (%)	N/A

N/A	Ramp inside XWalk1?	N/A	N/A	Ramp inside XWalk2?	N/A
	Road Slope (%)	3.2		Clear Space?	N/A
	Road X Slope (%)	2.2	N/A	Clear Space to XWalk (in)	N/A
N/A	Any Obstructions?	N/A	N/A	Storm Grate/Utility Hazard?	N/A
	Obstruction Type			Storm Grate/Utility Type	
		N/A			N/A
			Yes	Surface Condition? (G/P)	Good
			No	Curb Slope (%)	8.1

**Remove & Replace Curb Ramp With Two New Directional Ramps or Equivalent.**
