Access Compliance Report

Public Rights-of-Way

(Curb Ramps)

Intersection ID: 16516	Main Street: MEADOWDALE_LN	Cross Street: IDLEBROOK_DR	Location: E
ADA ID: 1F454EFDE9B9	Ramp Type: BlendTrans2	Initial Pass/Fail: Fail	Overall Compliance: No
		Severity Score: 12.5

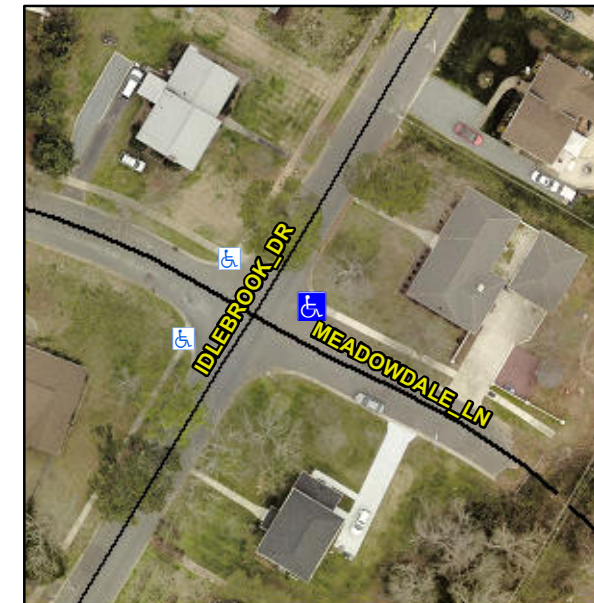
Not Found, R304.5.3

Compliance	Description	Data	Compliance	Description	Data
N/A	Ramp Length (in)	72.0	Yes	BlendTrans Slope (%)	3.5
Yes	Ramp Width (in)	48.0	No	BlendTrans XSlope (%)	5.1
N/A	Flare Type LT	N/A	N/A	Flare Type RT	N/A
N/A	Flare Slope LT (%)	N/A	N/A	Flare Slope RT (%)	N/A
N/A	Flare Traversable LT?	N/A	N/A	Flare Traversable RT?	N/A
N/A	Landing Length (in)	N/A	N/A	DWS Provided?	N/A
N/A	Landing Width (in)	N/A	N/A	DWS Contrast?	N/A
N/A	Landing Slope (%)	N/A	N/A	DWS Length (in)	N/A
N/A	Landing X Slope (%)	N/A	N/A	DWS Full Width?	N/A
N/A	Landing Curb? (Y/N)	N/A	N/A	DWS Offset (in)	N/A
N/A	Shared Landing?	N/A			
N/A	Gutter Ponding?	N/A	N/A	Gutter Slope (%)	N/A
N/A	Gutter Lip Ht (in)	N/A	N/A	Gutter X Slope (%)	N/A
N/A	Painted X Walk1?	No	N/A	Painted X Walk2?	No
	X Walk 1 Direction	To NW		X Walk 2 Direction	To SW
	X Walk 1 Width (in)	N/A		X Walk 2 Width (in)	N/A
	X Walk 1 Slope (%)	5.7		X Walk 2 Slope (%)	0.0
	X Walk 1 X Slope (%)	0.5		X Walk 2 X Slope (%)	4.7

N/A	Ramp inside XWalk1?	N/A	N/A	Ramp inside XWalk2?	N/A
	Road Slope (%)	3.9		Clear Space?	N/A
	Road X Slope (%)	4.1	N/A	Clear Space to XWalk (in)	N/A
N/A	Any Obstructions?	N/A	N/A	Storm Grate/Utility Hazard?	N/A
	Obstruction Type			Storm Grate/Utility Type	
		N/A			N/A
			Yes	Surface Condition? (G/P)	Good
			No	Curb Slope (%)	11.1

Possible Solutions:

Remove & Replace Curb Ramp With Two New Directional Ramps or Equivalent.

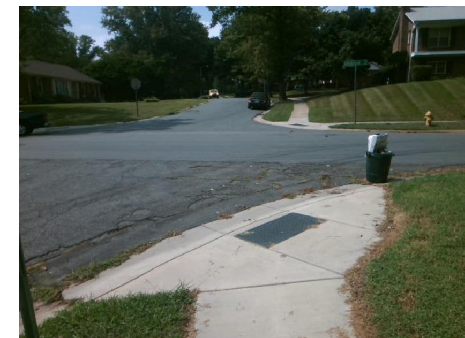
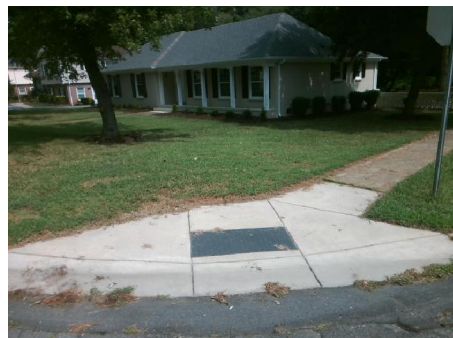
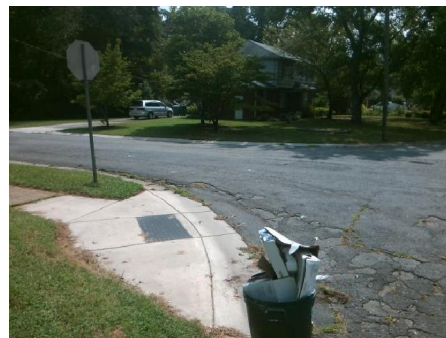
Street 1 Name IDLEBROOK DR
 Stop Condition-Street 1 None
 Street 2 Name MEADOWDALE LN
 Stop Condition-Street 2 StopSign
