Access Compliance Report

Public Rights-of-Way

(Curb Ramps)

Intersection ID: 3205	Main Street: LANSHIRE_CT	Cross Street: SHELLY_PINES_DR	Location: SW
ADA ID: 1F487FF1DBA6	Ramp Type: Perp	Initial Pass/Fail: Fail	Overall Compliance: No
		Severity Score: 1.25

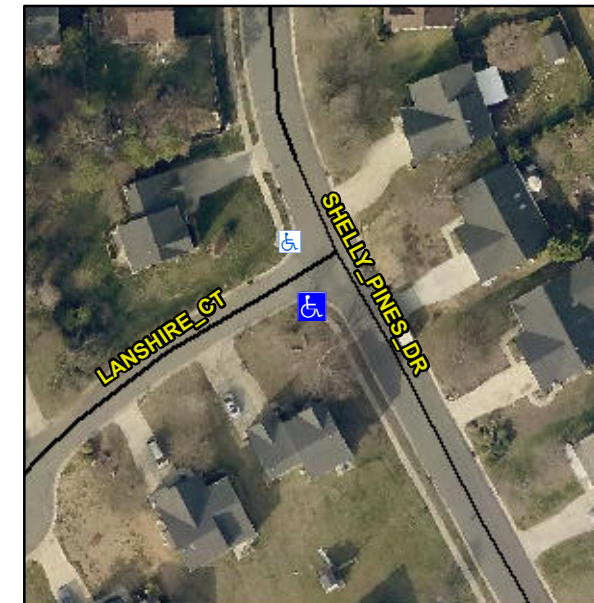
R304.5.3

Compliance	Description	Data	Compliance	Description	Data
N/A	Ramp Length (in)	47.5	Yes	Ramp Slope (%)	7.0
Yes	Ramp Width (in)	64.0	No	Ramp XSlope (%)	2.8
N/A	Flare Type LT	N/A	N/A	Flare Type RT	N/A
N/A	Flare Slope LT (%)	N/A	N/A	Flare Slope RT (%)	N/A
N/A	Flare Traversable LT?	N/A	N/A	Flare Traversable RT?	N/A
N/A	Landing Length (in)	N/A	N/A	DWS Provided?	N/A
N/A	Landing Width (in)	N/A	N/A	DWS Contrast?	N/A
N/A	Landing Slope (%)	N/A	N/A	DWS Length (in)	N/A
N/A	Landing X Slope (%)	N/A	N/A	DWS Full Width?	N/A
N/A	Landing Curb? (Y/N)	N/A	N/A	DWS Offset (in)	N/A
N/A	Shared Landing?	N/A			
N/A	Gutter Ponding?	N/A	N/A	Gutter Slope (%)	N/A
N/A	Gutter Lip Ht (in)	N/A	N/A	Gutter X Slope (%)	N/A
N/A	Painted X Walk1?	No	N/A	Painted X Walk2?	N/A
	X Walk 1 Direction	To N		X Walk 2 Direction	N/A
N/A	X Walk 1 Width (in)	N/A	N/A	X Walk 2 Width (in)	N/A
	X Walk 1 Slope (%)	4.2		X Walk 2 Slope (%)	N/A
	X Walk 1 X Slope (%)	0.2		X Walk 2 X Slope (%)	N/A

Remove & Replace Entire Ramp.

\$ 1850.00
