Intersection ID: 23278	Main Street: ALEXANDER_RD	Cross Street: WOODSHED_CR	Location:	NW
ADA ID: 1F5D8E1F32CF	Ramp Type: PerpDiag	Initial Pass/Fail: Fail	Overall Compliance: No	Severity Score: 26.25

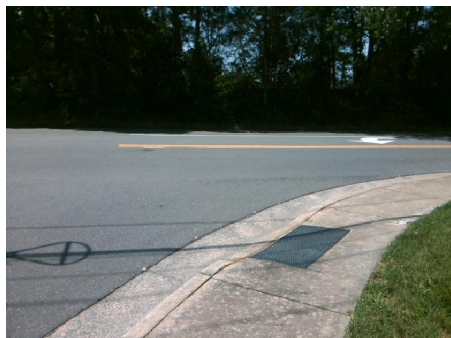
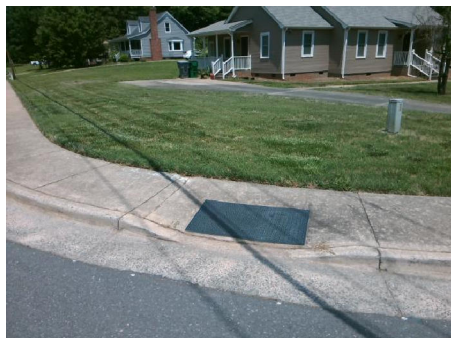
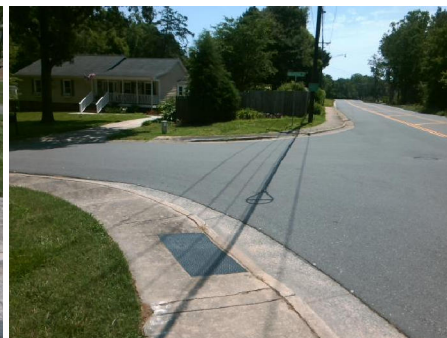
Possible Solutions:		Compliance	Description	Data	Compliance	Description	Data
	Remove & Replace Curb Ramp With Two New Directional Ramps or Equivalent.		N/A	Ramp Length (in)	48.0	No	Ramp Slope (%)	13.2
			Yes	Ramp Width (in)	48.0	No	Ramp XSlope (%)	2.8
			N/A	Flare Type LT	N/A	N/A	Flare Type RT	N/A
			N/A	Flare Slope LT (%)	N/A	N/A	Flare Slope RT (%)	N/A
			N/A	Flare Traversable LT?	N/A	N/A	Flare Traversable RT?	N/A
			N/A	Landing Length (in)	N/A	N/A	DWS Provided?	N/A
Surveyor Notes:			N/A	Landing Width (in)	N/A	N/A	DWS Contrast?	N/A
	N/A		N/A	Landing Slope (%)	N/A	N/A	DWS Length (in)	N/A
			N/A	Landing X Slope (%)	N/A	N/A	DWS Full Width?	N/A
			N/A	Landing Curb? (Y/N)	N/A	N/A	DWS Offset (in)	N/A
			N/A	Shared Landing?	N/A			
PROW/ADA:			N/A	Gutter Ponding?	N/A	N/A	Gutter Slope (%)	N/A
	Not Found, R304.2.2, R304.5.3		N/A	Gutter Lip Ht (in)	N/A	N/A	Gutter X Slope (%)	N/A

N/A	Painted X Walk1?	No	N/A	Painted X Walk2?	No
				X Walk 1 Direction	To SW		X Walk 2 Direction	To SE
			N/A	X Walk 1 Width (in)	N/A	N/A	X Walk 2 Width (in)	N/A
				X Walk 1 Slope (%)	7.6		X Walk 2 Slope (%)	1.9
				X Walk 1 X Slope (%)	2.0		X Walk 2 X Slope (%)	6.2
			N/A	Ramp inside XWalk1?	N/A	N/A	Ramp inside XWalk2?	N/A
				Road Slope (%)	0.7	N/A	Clear Space?	N/A
				Road X Slope (%)	8.0	N/A	Clear Space to XWalk (in)	N/A
			N/A	Any Obstructions?	N/A	N/A	Storm Grate/Utility Hazard?	N/A
				Obstruction Type			Storm Grate/Utility Type	
Total Cost:	\$ 3200.00				N/A			N/A
						Yes	Surface Condition? (G/P)	Good
