# Access Compliance Report

## Public Rights-of-Way

### (Curb Ramps)

Intersection ID: 52536	Main Street: VINOY_BV	Cross Street: IBM_DR	Location: NE
ADA ID: 1F614ED5E6F0	Ramp Type: Perp	Initial Pass/Fail: Fail	Overall Compliance: No
Severity Score: 1.25			
Codes/Mitigation Info/Possible Solution		Field Measurements/Component Compliance

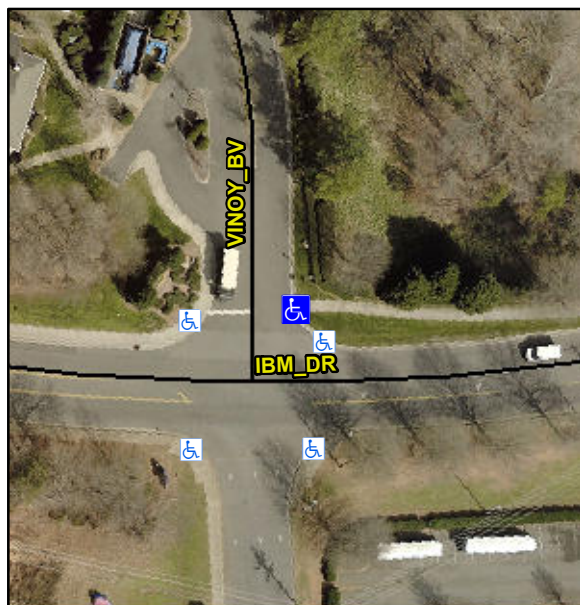
**Not Found, R304.5.3**

Compliance	Description	Data	Compliance	Description	Data
N/A	Ramp Length (in)	64.0	Yes	Ramp Slope (%)	5.2
Yes	Ramp Width (in)	71.0	No	Ramp XSlope (%)	2.6
N/A	Flare Type LT	N/A	N/A	Flare Type RT	N/A
N/A	Flare Slope LT (%)	N/A	N/A	Flare Slope RT (%)	N/A
N/A	Flare Traversable LT?	N/A	N/A	Flare Traversable RT?	N/A
N/A	Landing Length (in)	N/A	N/A	DWS Provided?	N/A
N/A	Landing Width (in)	N/A	N/A	DWS Contrast?	N/A
N/A	Landing Slope (%)	N/A	N/A	DWS Length (in)	N/A
N/A	Landing X Slope (%)	N/A	N/A	DWS Full Width?	N/A
N/A	Landing Curb? (Y/N)	N/A	N/A	DWS Offset (in)	N/A
N/A	Shared Landing?	N/A			
N/A	Gutter Ponding?	N/A	N/A	Gutter Slope (%)	N/A
N/A	Gutter Lip Ht (in)	1.0	N/A	Gutter X Slope (%)	N/A
N/A	Painted X Walk1?	No	N/A	Painted X Walk2?	N/A
	X Walk 1 Direction	To W		X Walk 2 Direction	N/A
N/A	X Walk 1 Width (in)	N/A	N/A	X Walk 2 Width (in)	N/A
	X Walk 1 Slope (%)	3.9		X Walk 2 Slope (%)	N/A
	X Walk 1 X Slope (%)	5.1		X Walk 2 X Slope (%)	N/A

N/A	Ramp inside XWalk1?	N/A	N/A	Ramp inside XWalk2?	N/A
	Road Slope (%)	N/A	N/A	Clear Space?	N/A
	Road X Slope (%)	N/A	N/A	Clear Space to XWalk (in)	N/A
N/A	Any Obstructions?	N/A	N/A	Storm Grate/Utility Hazard?	N/A
	Obstruction Type			Storm Grate/Utility Type	
		N/A			N/A
		Yes		Surface Condition? (G/P)	Good

Possible Solutions:

**Remove & Replace Entire Ramp.**

Total Cost: \$ 1850.00
