Access Compliance Report

Public Rights-of-Way

(Curb Ramps)

Intersection ID: 8852	Main Street: DOGWOOD_AV	Cross Street: GRIMES_ST	Location: W
ADA ID: 1F66A1A0BE62	Ramp Type: Perp	Initial Pass/Fail: Fail	Overall Compliance: No
Severity Score: 12.5			
Codes/Mitigation Info/Possible Solution		Field Measurements/Component Compliance

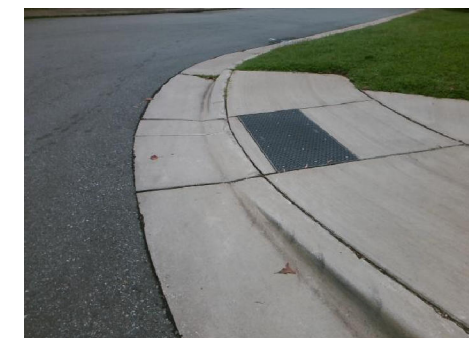
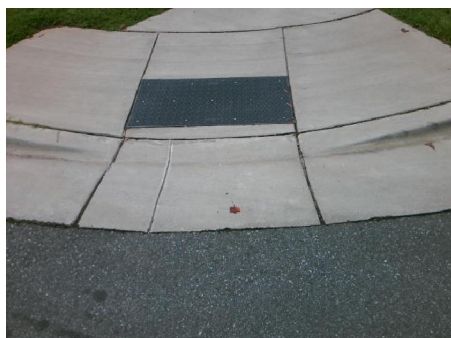
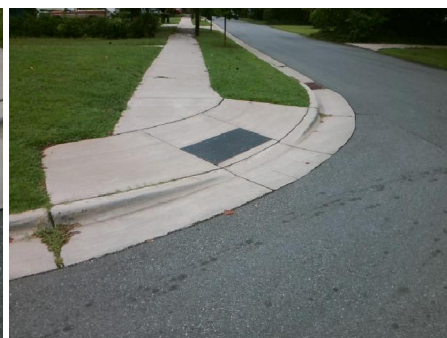
Not Found, R304.5.3

Compliance	Description	Data	Compliance	Description	Data
N/A	Ramp Length (in)	60.5	Yes	Ramp Slope (%)	8.2
Yes	Ramp Width (in)	48.0	No	Ramp XSlope (%)	5.2
N/A	Flare Type LT	N/A	N/A	Flare Type RT	N/A
N/A	Flare Slope LT (%)	N/A	N/A	Flare Slope RT (%)	N/A
N/A	Flare Traversable LT?	N/A	N/A	Flare Traversable RT?	N/A
N/A	Landing Length (in)	N/A	N/A	DWS Provided?	N/A
N/A	Landing Width (in)	N/A	N/A	DWS Contrast?	N/A
N/A	Landing Slope (%)	N/A	N/A	DWS Length (in)	N/A
N/A	Landing X Slope (%)	N/A	N/A	DWS Full Width?	N/A
N/A	Landing Curb? (Y/N)	N/A	N/A	DWS Offset (in)	N/A
N/A	Shared Landing?	N/A			
N/A	Gutter Ponding?	N/A	N/A	Gutter Slope (%)	N/A
N/A	Gutter Lip Ht (in)	N/A	N/A	Gutter X Slope (%)	N/A
N/A	Painted X Walk1?	No	N/A	Painted X Walk2?	N/A
	X Walk 1 Direction	To SE		X Walk 2 Direction	N/A
N/A	X Walk 1 Width (in)	N/A	N/A	X Walk 2 Width (in)	N/A
	X Walk 1 Slope (%)	1.6		X Walk 2 Slope (%)	N/A
	X Walk 1 X Slope (%)	3.8		X Walk 2 X Slope (%)	N/A

N/A	Ramp inside XWalk1?	N/A	N/A	Ramp inside XWalk2?	N/A
	Road Slope (%)	N/A	N/A	Clear Space?	N/A
	Road X Slope (%)	N/A	N/A	Clear Space to XWalk (in)	N/A
N/A	Any Obstructions?	N/A	N/A	Storm Grate/Utility Hazard?	N/A
	Obstruction Type			Storm Grate/Utility Type	
		N/A			N/A
			Yes	Surface Condition? (G/P)	Good

Remove & Replace Entire Ramp.
