Access Compliance Report

Public Rights-of-Way

(Curb Ramps)

Intersection ID: 15079	Main Street: ALBEMARLE_RD	Cross Street: POINT_LAKE_DR	Location: NW
ADA ID: 1F749860AE0B	Ramp Type: Perp	Initial Pass/Fail: Fail	Overall Compliance: No
Severity Score: 61.25			
Codes/Mitigation Info/Possible Solution		Field Measurements/Component Compliance

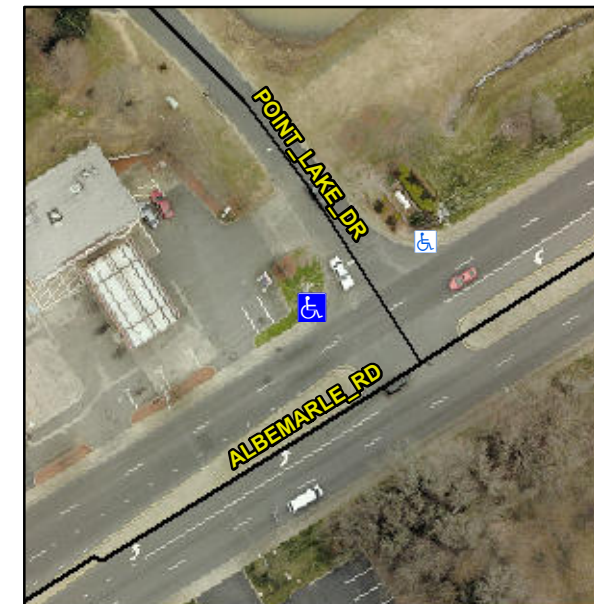
Not Found, R304.5.1, R304.2.2, R304.5.3, R302.7

Compliance	Description	Data	Compliance	Description	Data
N/A	Ramp Length (in)	60.5	No	Ramp Slope (%)	11.7
No	Ramp Width (in)	47.0	No	Ramp XSlope (%)	7.9
N/A	Flare Type LT	N/A	N/A	Flare Type RT	N/A
N/A	Flare Slope LT (%)	N/A	N/A	Flare Slope RT (%)	N/A
N/A	Flare Traversable LT?	N/A	N/A	Flare Traversable RT?	N/A
N/A	Landing Length (in)	N/A	N/A	DWS Provided?	N/A
N/A	Landing Width (in)	N/A	N/A	DWS Contrast?	N/A
N/A	Landing Slope (%)	N/A	N/A	DWS Length (in)	N/A
N/A	Landing X Slope (%)	N/A	N/A	DWS Full Width?	N/A
N/A	Landing Curb? (Y/N)	N/A	N/A	DWS Offset (in)	N/A
N/A	Shared Landing?	N/A			
N/A	Gutter Ponding?	N/A	N/A	Gutter Slope (%)	N/A
N/A	Gutter Lip Ht (in)	N/A	N/A	Gutter X Slope (%)	N/A
N/A	Painted X Walk1?	No	N/A	Painted X Walk2?	N/A
	X Walk 1 Direction	To E		X Walk 2 Direction	N/A
N/A	X Walk 1 Width (in)	N/A	N/A	X Walk 2 Width (in)	N/A
	X Walk 1 Slope (%)	3.0		X Walk 2 Slope (%)	N/A
	X Walk 1 X Slope (%)	7.0		X Walk 2 X Slope (%)	N/A

N/A	Ramp inside XWalk1?	N/A	N/A	Ramp inside XWalk2?	N/A
	Road Slope (%)	N/A	N/A	Clear Space?	N/A
	Road X Slope (%)	N/A	N/A	Clear Space to XWalk (in)	N/A
N/A	Any Obstructions?	N/A	N/A	Storm Grate/Utility Hazard?	N/A
	Obstruction Type			Storm Grate/Utility Type	
		N/A			N/A
		No		Surface Condition? (G/P)	Poor

Possible Solutions:

Remove & Replace Entire Ramp.
