Access Compliance Report Public Rights-of-Way (Curb Ramps)

Intersection ID: 10065 Main Street: COMMERCIAL_AV Cross Street: THE_PLAZA Location: SE

ADA ID: 1F77B6130594 Ramp Type: ParaDiag Initial Pass/Fail: Fail Overall Compliance: No Severity Score: 13.75

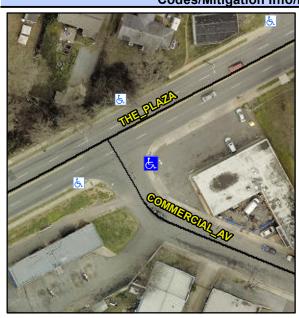
ata
NoRamp Slope LT (%)9.2YesRamp Slope RT (%)NoRamp XSlope LT (%)2.3NoRamp XSlope RT (%)N/ALanding Length (in)N/AN/ADWS Provided?	59.0
No Ramp XSlope LT (%) N/A Landing Length (in) N/A DWS Provided?	54.0
N/A Landing Length (in) N/A N/A DWS Provided?	5.3

4.1
N/A Landing Width (in) N/A N/A DWS Contrast?	N/A
	N/A
N/A Landing Slope (%) N/A N/A DWS Length (in)	N/A
N/A Landing X Slope (%) N/A N/A DWS Full Width?	N/A
N/A Landing Curb? (Y/N) N/A N/A DWS Offset (in)	N/A
N/A Shared Landing? N/A	
N/A Gutter Ponding? N/A N/A Gutter Slope (%)	N/A
N/A Gutter Lip Ht (in) N/A N/A Gutter X Slope (%)	N/A
N/A Painted X Walk1? No N/A Painted X Walk2?	No
X Walk 1 Direction To NW X Walk 2 Direction To	sw
N/A X Walk 1 Width (in) N/A N/A X Walk 2 Width (in)	N/A
X Walk 1 Slope (%) 2.3 X Walk 2 Slope (%)	0.5
X Walk 1 X Slope (%) 0.5 X Walk 2 X Slope (%)	2.0
N/A Ramp inside XWalk1? N/A Ramp inside XWalk2?	N/A
Road Slope (%) 0.1 N/A Clear Space?	N/A
Road X Slope (%) 5.3 N/A Clear Space to XWalk (in)	N/A
N/A Any Obstructions? N/A N/A Storm Grate/Utility Hazard?	N/A
Obstruction Type Storm Grate/Utility Type	
N/A	N/A
Yes Surface Condition? (G/P) G	ood
N/A Curb Slope (%)	8.4

Possible Solutions:

Remove & Replace Curb Ramp With
Two New Directional Ramps or
Equivalent.

R304.3.2, R304.5.3

Total Cost: \$ 3200.00
