Access Compliance Report Public Rights-of-Way (Curb Ramps)

Intersection ID: 13133 Main Street: S_CALDWELL_ST Cross Street: E_STONEWALL_ST Location: E

ADA ID: 1F78AB27B072 Ramp Type: BlendTrans1 Initial Pass/Fail: Pass Overall Compliance: No Severity Score: 20.25

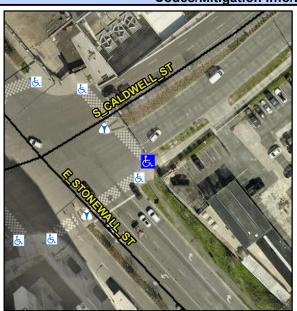
R304.5.3, R302.7.2, R304.5.4, R302.3, R402.2

Possible Solutions:

Remove & Replace Curb Ramp With
Two New Directional Ramps or
Equivalent. Remove & Replace
Gutter. Utility Present.
