# Access Compliance Report

## Public Rights-of-Way

### (Curb Ramps)

Intersection ID: 46765	Main Street: FRIENDSHIP_VILLAGE_PL	Cross Street: MISSIONARY_AV	Location: NW
ADA ID: 1F7CE2698FAC	Ramp Type: Combination1Diag	Initial Pass/Fail: Fail	Overall Compliance: No
		Severity Score: 0

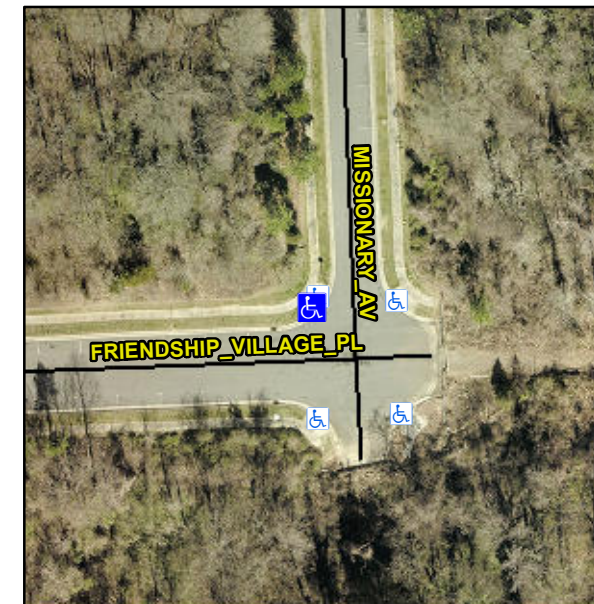
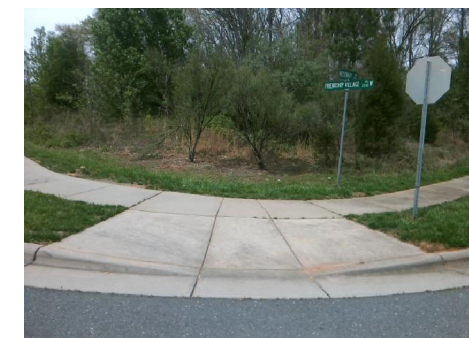
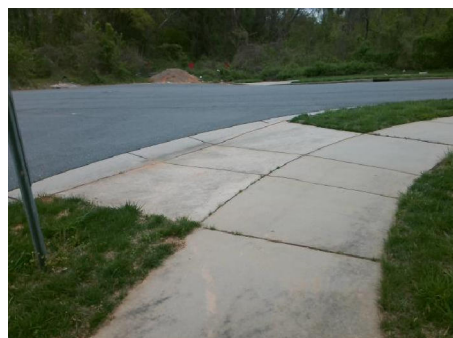
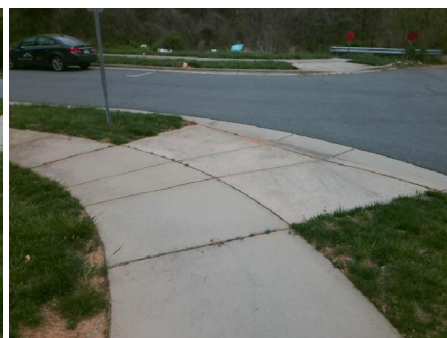
Compliance	Description	Data	Compliance	Description	Data
N/A	Ramp Length LT (in)	58.5	N/A	Ramp Length RT (in)	51.5
Yes	Ramp Width LT (in)	60.5	Yes	Ramp Width RT (in)	60.0
No	Ramp Slope LT (%)	10.4	No	Ramp Slope RT (%)	8.6
No	Ramp XSlope LT (%)	4.8	No	Ramp XSlope RT (%)	4.4
N/A	Ramp Length (in)	75.0	No	Ramp Slope (%)	9.3
No	Ramp Width (in)	37.0	No	Ramp XSlope (%)	6.9
N/A	Flare Type LT	N/A	N/A	Flare Type RT	N/A
N/A	Flare Slope LT (%)	N/A	N/A	Flare Slope RT (%)	N/A
N/A	Flare Traversable LT?	N/A	N/A	Flare Traversable RT?	N/A
N/A	Landing Length (in)	N/A	N/A	DWS Provided?	N/A
N/A	Landing Width (in)	N/A	N/A	DWS Contrast?	N/A
N/A	Landing Slope (%)	N/A	N/A	DWS Length (in)	N/A
N/A	Landing X Slope (%)	N/A	N/A	DWS Full Width?	N/A
N/A	Landing Curb? (Y/N)	N/A	N/A	DWS Offset (in)	N/A
N/A	Shared Landing?	N/A			
N/A	Gutter Ponding?	N/A	N/A	Gutter Slope (%)	N/A
N/A	Gutter Lip Ht (in)	N/A	N/A	Gutter X Slope (%)	N/A
N/A	Painted X Walk1?	No	N/A	Painted X Walk2?	No

X Walk 1 Direction	To S		X Walk 2 Direction	To E
	X Walk 1 Width (in)	N/A		X Walk 2 Width (in)	N/A
	X Walk 1 Slope (%)	4.5		X Walk 2 Slope (%)	0.5
	X Walk 1 X Slope (%)	4.2		X Walk 2 X Slope (%)	3.4
N/A	Ramp inside XWalk1?	N/A	N/A	Ramp inside XWalk2?	N/A
	Road Slope (%)	6.3		Clear Space?	N/A
	Road X Slope (%)	1.0	N/A	Clear Space to XWalk (in)	N/A
			N/A	Any Obstruction?	N/A
				Obstruction Type	N/A
			N/A	Storm Grate/Utility Hazard?	N/A
				Storm Grate/Utility Type	N/A
Yes	Surface Condition? (G/P)	Good			
	Curb Slope (%)	2.6

**Remove & Replace Curb Ramp With Two New Directional Ramps or Equivalent.**
