Access Compliance Report

Public Rights-of-Way

(Curb Ramps)

Intersection ID: 28495	Main Street: TYVOLA_CENTRE_DR	Cross Street: CAMERON_WALK_CT	Location: NW
ADA ID: 1F82BE04FEE3	Ramp Type: Perp	Initial Pass/Fail: Fail	Overall Compliance: No
Severity Score: 13.75			
Codes/Mitigation Info/Possible Solution		Field Measurements/Component Compliance

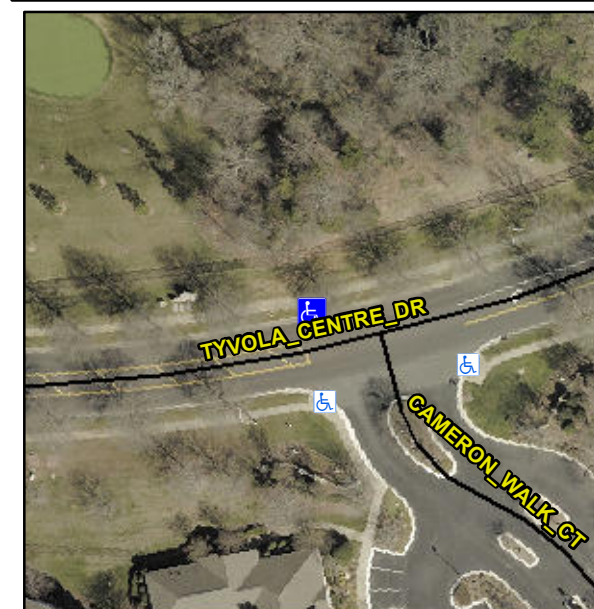
Compliance	Description	Data	Compliance	Description	Data
N/A	Ramp Length (in)	72.0	No	Ramp Slope (%)	11.4
Yes	Ramp Width (in)	55.0	No	Ramp XSlope (%)	3.9
N/A	Flare Type LT	N/A	N/A	Flare Type RT	N/A
N/A	Flare Slope LT (%)	N/A	N/A	Flare Slope RT (%)	N/A
N/A	Flare Traversable LT?	N/A	N/A	Flare Traversable RT?	N/A
N/A	Landing Length (in)	N/A	N/A	DWS Provided?	N/A
N/A	Landing Width (in)	N/A	N/A	DWS Contrast?	N/A
N/A	Landing Slope (%)	N/A	N/A	DWS Length (in)	N/A
N/A	Landing X Slope (%)	N/A	N/A	DWS Full Width?	N/A
N/A	Landing Curb? (Y/N)	N/A	N/A	DWS Offset (in)	N/A
N/A	Shared Landing?	N/A			
N/A	Gutter Ponding?	N/A	N/A	Gutter Slope (%)	N/A
N/A	Gutter Lip Ht (in)	N/A	N/A	Gutter X Slope (%)	N/A
N/A	Painted X Walk1?	No	N/A	Painted X Walk2?	N/A
	X Walk 1 Direction	To S		X Walk 2 Direction	N/A
N/A	X Walk 1 Width (in)	N/A	N/A	X Walk 2 Width (in)	N/A
	X Walk 1 Slope (%)	4.1		X Walk 2 Slope (%)	N/A
	X Walk 1 X Slope (%)	2.6		X Walk 2 X Slope (%)	N/A

N/A	Ramp inside XWalk1?	N/A	N/A	Ramp inside XWalk2?	N/A
	Road Slope (%)	N/A	N/A	Clear Space?	N/A
	Road X Slope (%)	N/A	N/A	Clear Space to XWalk (in)	N/A
N/A	Any Obstructions?	N/A	N/A	Storm Grate/Utility Hazard?	N/A
	Obstruction Type			Storm Grate/Utility Type	
		N/A			N/A
		Yes		Surface Condition? (G/P)	Good

Possible Solutions:

Remove & Replace Entire Ramp.

R304.2.2, R304.5.3
