Access Compliance Report Public Rights-of-Way (Curb Ramps)

Intersection ID: 27987 Main Street: PROVIDENCE_RD_WEST Cross Street: ROTHESAY_DR Location: SE

ADA ID: 1F87A794CFED Ramp Type: BlendTrans1 Initial Pass/Fail: Fail Overall Compliance: No Severity Score: 12.5

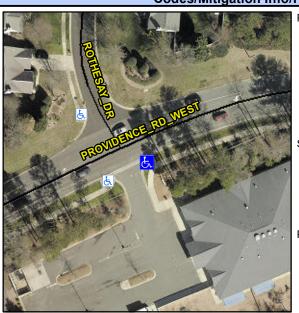
Comp	liance Description	Data	nta Compliance Description		Data
	N/A	Ramp Length (in)	91.0	Yes	BlendTrans Slope (%)	1.4
	Yes	Ramp Width (in)	48.0	No	BlendTrans XSlope (%)	5.2
	N/A	Flare Type LT	N/A	N/A	Flare Type RT	N/A
	N/A	Flare Slope LT (%)	N/A	N/A	Flare Slope RT (%)	N/A
	N/A	Flare Traversable LT?	N/A	N/A	Flare Traversable RT?	N/A
	N/A	Landing Length (in)	N/A	N/A	DWS Provided?	N/A
	N/A	Landing Width (in)	N/A	N/A	DWS Contrast?	N/A
	N/A	Landing Slope (%)	N/A	N/A	DWS Length (in)	N/A
	N/A	Landing X Slope (%)	N/A	N/A	DWS Full Width?	N/A
	N/A	Landing Curb? (Y/N)	N/A	N/A	DWS Offset (in)	N/A
	N/A	Shared Landing?	N/A			
	N/A	Gutter Ponding?	N/A	N/A	Gutter Slope (%)	N/A
	N/A	Gutter Lip Ht (in)	N/A	N/A	Gutter X Slope (%)	N/A
	N/A	Painted X Walk1?	No	N/A	Painted X Walk2?	No
		X Walk 1 Direction	To NW		X Walk 2 Direction	To SW
		X Walk 1 Width (in)	N/A		X Walk 2 Width (in)	N/A
		X Walk 1 Slope (%)	2.5		X Walk 2 Slope (%)	3.3

X Walk 1 X Slope (%)	5.4		X Walk 2 X Slope (%)	1.6
	N/A	Ramp inside XWalk1?	N/A	N/A	Ramp inside XWalk2?	N/A
		Road Slope (%)	3.1		Clear Space?	N/A
		Road X Slope (%)	0.3	N/A	Clear Space to XWalk (in)	N/A
	N/A	Any Obstructions?	N/A	N/A	Storm Grate/Utility Hazard?	N/A
		Obstruction Type		l	Storm Grate/Utility Type	
			N/A	l		N/A
				Yes	Surface Condition? (G/P)	Good
,				No	Curb Slope (%)	6.4

Remove & Replace Curb Ramp With Two New Directional Ramps or Equivalent.
