## **Access Compliance Report Public Rights-of-Way** (Curb Ramps)

Intersection ID: 25769 Main Street: PINEVILLE-MATTHEWS RD Cross Street: CARMEL\_COMMONS\_BV Location: SW **ADA ID: 1F8BA9096CF0** Ramp Type: PerpDiag Initial Pass/Fail: Fail **Overall Compliance: No Severity Score:** 25

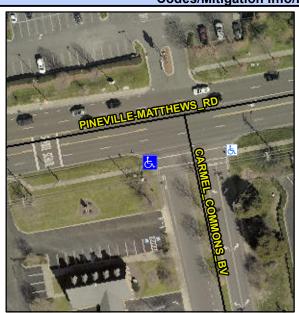
Field Measurements/Component Compliance					
Compliance Description D		Data	Comp	liance Description	Data
N/A	Ramp Length (in)	102.0	Yes	Ramp Slope (%)	5.1
Yes	Ramp Width (in)	48.0	No	Ramp XSlope (%)	7.4
N/A	Flare Type LT	N/A	N/A	Flare Type RT	N/A
N/A	Flare Slope LT (%)	N/A	N/A	Flare Slope RT (%)	N/A
N/A	Flare Traversable LT?	N/A	N/A	Flare Traversable RT?	N/A
N/A	Landing Length (in)	N/A	N/A	DWS Provided?	N/A
N/A	Landing Width (in)	N/A	N/A	DWS Contrast?	N/A
N/A	Landing Slope (%)	N/A	N/A	DWS Length (in)	N/A
N/A	Landing X Slope (%)	N/A	N/A	DWS Full Width?	N/A
N/A	Landing Curb? (Y/N)	N/A	N/A	DWS Offset (in)	N/A
N/A	Shared Landing?	N/A			
N/A	Gutter Ponding?	N/A	N/A	Gutter Slope (%)	N/A
N/A	Gutter Lip Ht (in)	N/A	N/A	Gutter X Slope (%)	N/A
N/A	Painted X Walk1?	Yes	N/A	Painted X Walk2?	No
	X Walk 1 Direction	То Е		X Walk 2 Direction	To N
N/A	X Walk 1 Width (in)	125.0	N/A	X Walk 2 Width (in)	N/A
	X Walk 1 Slope (%)	5.2		X Walk 2 Slope (%)	1.0

X Walk 1 X Slope (%)	0.9		X Walk 2 X Slope (%)	3.1
N/A	Ramp inside XWalk1?	Yes	N/A	Ramp inside XWalk2?	N/A
	Road Slope (%)	2.9	N/A	Clear Space?	N/A
	Road X Slope (%)	3.6	N/A	Clear Space to XWalk (in)	N/A
N/A	Any Obstructions?	N/A	N/A	Storm Grate/Utility Hazard?	N/A
	Obstruction Type			Storm Grate/Utility Type	
		N/A			N/A
			Yes	Surface Condition? (G/P)	Good

Possible Solutions: **Remove & Replace Curb Ramp With** Two New Directional Ramps or Equivalent. Surveyor Notes: N/A PROW/ADA: Not Found, R304.5.3
