# Access Compliance Report

## Public Rights-of-Way

### (Curb Ramps)

Intersection ID: N/A	Main Street: CASCADE_POINTE_BV	Cross Street: N/A	Location: NW
ADA ID: 1F8BB1322291	Ramp Type: PerpDiag	Initial Pass/Fail: Fail	Overall Compliance: No
		Severity Score: 22.5

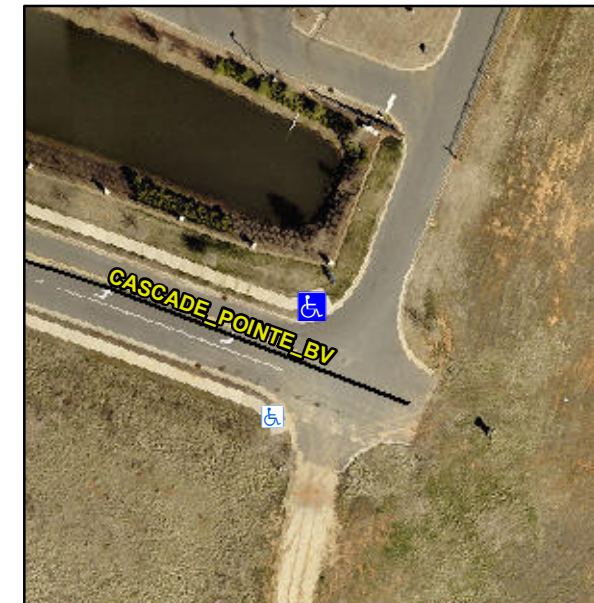
**Not Found, R304.5.1, R304.2.2, R304.5.3**

Compliance	Description	Data	Compliance	Description	Data
N/A	Ramp Length (in)	80.0	No	Ramp Slope (%)	9.5
No	Ramp Width (in)	46.0	No	Ramp XSlope (%)	3.9
N/A	Flare Type LT	N/A	N/A	Flare Type RT	N/A
N/A	Flare Slope LT (%)	N/A	N/A	Flare Slope RT (%)	N/A
N/A	Flare Traversable LT?	N/A	N/A	Flare Traversable RT?	N/A
N/A	Landing Length (in)	N/A	N/A	DWS Provided?	N/A
N/A	Landing Width (in)	N/A	N/A	DWS Contrast?	N/A
N/A	Landing Slope (%)	N/A	N/A	DWS Length (in)	N/A
N/A	Landing X Slope (%)	N/A	N/A	DWS Full Width?	N/A
N/A	Landing Curb? (Y/N)	N/A	N/A	DWS Offset (in)	N/A
N/A	Shared Landing?	N/A			
N/A	Gutter Ponding?	N/A	N/A	Gutter Slope (%)	N/A
N/A	Gutter Lip Ht (in)	N/A	N/A	Gutter X Slope (%)	N/A
N/A	Painted X Walk1?	No	N/A	Painted X Walk2?	No
	X Walk 1 Direction	To S		X Walk 2 Direction	To E
N/A	X Walk 1 Width (in)	N/A	N/A	X Walk 2 Width (in)	N/A
	X Walk 1 Slope (%)	0.7		X Walk 2 Slope (%)	1.8
	X Walk 1 X Slope (%)	3.2		X Walk 2 X Slope (%)	3.1

N/A	Ramp inside XWalk1?	N/A	N/A	Ramp inside XWalk2?	N/A
	Road Slope (%)	4.4	N/A	Clear Space?	N/A
	Road X Slope (%)	0.3	N/A	Clear Space to XWalk (in)	N/A
N/A	Any Obstructions?	N/A	N/A	Storm Grate/Utility Hazard?	N/A
	Obstruction Type			Storm Grate/Utility Type	
		N/A			N/A
			Yes	Surface Condition? (G/P)	Good

**Remove & Replace Curb Ramp With Two New Directional Ramps or Equivalent.**

Total Cost: \$ 3200.00
