# Access Compliance Report

## Public Rights-of-Way

### (Curb Ramps)

| Intersection ID: 29354 | Main Street: OSAGE_CR | Cross Street: TETON_TL | Location: SW |

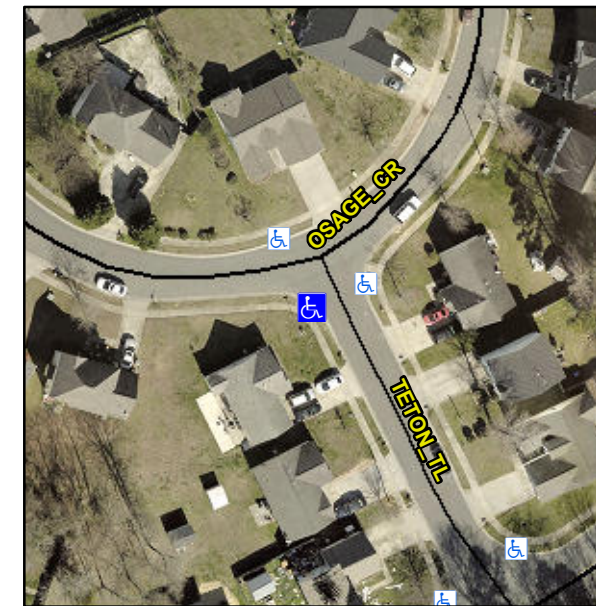
**CURB GAP 2.5**

**Not Found, R304.5.1, R304.5.3**

| Compliance | Description | Data | Compliance | Description | Data |
|---|---|---|---|---|---|
| N/A | Ramp Length (in) | 46.5 | Yes | BlendTrans Slope (%) | 4.4 |
| No | Ramp Width (in) | 43.0 | No | BlendTrans XSlope (%) | 3.9 |

**Remove & Replace Curb Ramp With Two New Directional Ramps or Equivalent.**
