Access Compliance Report

Public Rights-of-Way (Curb Ramps)

Intersection ID: N/A	Main Street: 7TH_ST	Cross Street: N/A	Location: SE
ADA ID: 1F9526A991B3	Ramp Type: PerpDiag	Initial Pass/Fail: Pass	Overall Compliance: No
Severity Score: 0.25			
Codes/Mitigation Info/Possible Solution		Field Measurements/Component Compliance

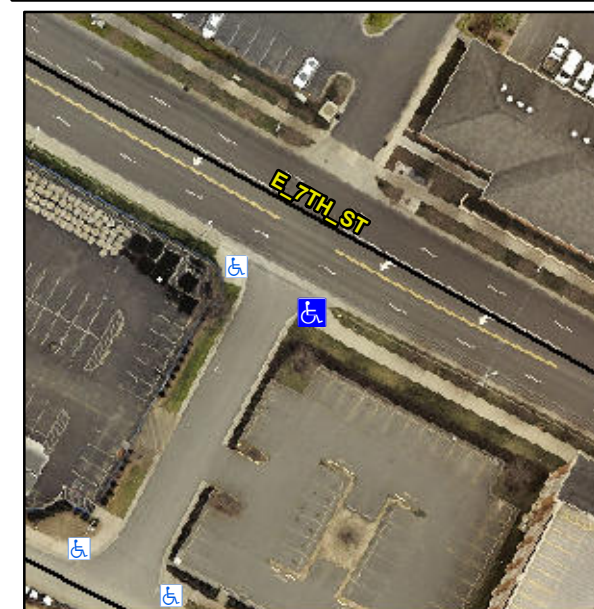
Not Found, R304.5.3

Compliance	Description	Data	Compliance	Description	Data
N/A	Ramp Length (in)	86.0	Yes	Ramp Slope (%)	5.5
Yes	Ramp Width (in)	48.0	No	Ramp XSlope (%)	4.4
N/A	Flare Type LT	Sloped	N/A	Flare Type RT	N/A
N/A	Flare Slope LT (%)	5.9	N/A	Flare Slope RT (%)	3.0
N/A	Flare Traversable LT?	No	N/A	Flare Traversable RT?	No
Yes	Landing Length (in)	61.0	Yes	DWS Provided?	Yes
Yes	Landing Width (in)	48.0	Yes	DWS Contrast?	Yes
Yes	Landing Slope (%)	1.2	Yes	DWS Length (in)	24.5
Yes	Landing X Slope (%)	1.3	Yes	DWS Full Width?	Yes
N/A	Landing Curb? (Y/N)	No	Yes	DWS Offset (in)	1.5
N/A	Shared Landing?	No			
Yes	Gutter Ponding?	No	Yes	Gutter Slope (%)	1.5
Yes	Gutter Lip Ht (in)	0.0	Yes	Gutter X Slope (%)	0.7
N/A	Painted X Walk1?	No	N/A	Painted X Walk2?	No
	X Walk 1 Direction	To NE		X Walk 2 Direction	To NW
N/A	X Walk 1 Width (in)	N/A	N/A	X Walk 2 Width (in)	N/A
	X Walk 1 Slope (%)	4.8		X Walk 2 Slope (%)	2.4
	X Walk 1 X Slope (%)	0.6		X Walk 2 X Slope (%)	2.0

N/A	Ramp inside XWalk1?	N/A	N/A	Ramp inside XWalk2?	N/A
	Road Slope (%)	1.1	N/A	Clear Space?	Yes
	Road X Slope (%)	2.8	N/A	Clear Space to XWalk (in)	N/A
Yes	Any Obstructions?	No	Yes	Storm Grate/Utility Hazard?	No
	Obstruction Type			Storm Grate/Utility Type	
		N/A			N/A
			Yes	Surface Condition? (G/P)	Good

Remove & Replace Curb Ramp With Two New Directional Ramps or Equivalent.
