Access Compliance Report

Public Rights-of-Way

(Curb Ramps)

Intersection ID: 44317	Main Street: E_9TH_ST	Cross Street: N_CALDWELL_ST	Location: E
ADA ID: 1F972359CD57	Ramp Type: PerpDiag	Initial Pass/Fail: Fail	Overall Compliance: No
Severity Score: 8.75			
Codes/Mitigation Info/Possible Solution		Field Measurements/Component Compliance

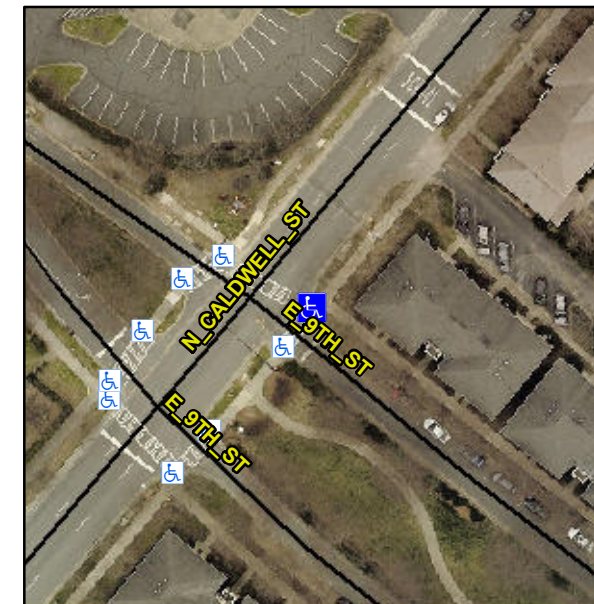
Not Found, R304.5.1

Compliance	Description	Data	Compliance	Description	Data
N/A	Ramp Length (in)	52.0	Yes	Ramp Slope (%)	6.3
No	Ramp Width (in)	42.0	Yes	Ramp XSlope (%)	1.2
N/A	Flare Type LT	N/A	N/A	Flare Type RT	N/A
N/A	Flare Slope LT (%)	N/A	N/A	Flare Slope RT (%)	N/A
N/A	Flare Traversable LT?	N/A	N/A	Flare Traversable RT?	N/A
N/A	Landing Length (in)	N/A	N/A	DWS Provided?	N/A
N/A	Landing Width (in)	N/A	N/A	DWS Contrast?	N/A
N/A	Landing Slope (%)	N/A	N/A	DWS Length (in)	N/A
N/A	Landing X Slope (%)	N/A	N/A	DWS Full Width?	N/A
N/A	Landing Curb? (Y/N)	N/A	N/A	DWS Offset (in)	N/A
N/A	Shared Landing?	N/A			
N/A	Gutter Ponding?	N/A	N/A	Gutter Slope (%)	N/A
N/A	Gutter Lip Ht (in)	N/A	N/A	Gutter X Slope (%)	N/A
N/A	Painted X Walk1?	Yes	N/A	Painted X Walk2?	Yes
	X Walk 1 Direction	To NW		X Walk 2 Direction	To SW
N/A	X Walk 1 Width (in)	110.0	N/A	X Walk 2 Width (in)	102.5
	X Walk 1 Slope (%)	3.6		X Walk 2 Slope (%)	4.2
	X Walk 1 X Slope (%)	0.9		X Walk 2 X Slope (%)	0.6

N/A	Ramp inside XWalk1?	Yes	N/A	Ramp inside XWalk2?	Yes
	Road Slope (%)	0.8	N/A	Clear Space?	N/A
	Road X Slope (%)	3.9	N/A	Clear Space to XWalk (in)	N/A
N/A	Any Obstructions?	N/A	N/A	Storm Grate/Utility Hazard?	N/A
	Obstruction Type			Storm Grate/Utility Type	
		N/A			N/A
		Yes		Surface Condition? (G/P)	Good

Remove & Replace Curb Ramp With Two New Directional Ramps or Equivalent.
