Access Compliance Report

Public Rights-of-Way

(Curb Ramps)

| Intersection ID: 4854 | Main Street: FARLOW_RD | Cross Street: WADE_E_MORGAN_RD | Location: SW |

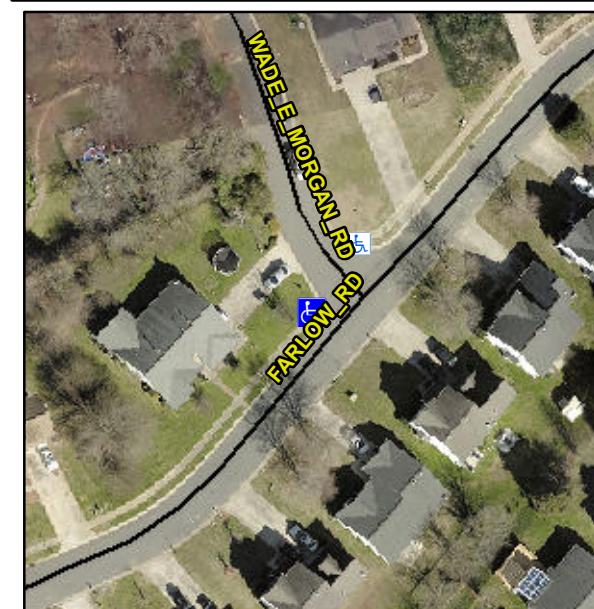
| ADA ID: 1FA6634D0D45 | Ramp Type: Perp | Initial Pass/Fail: Fail | Overall Compliance: No |
| Severity Score: 8.75 | | | |

Not Found, R304.5.1

| Compliance | Description | Data | Compliance | Description | Data |
|---|---|---|---|---|---|
| N/A | Ramp Length (in) | 45.0 | Yes | Ramp Slope (%) | 5.3 |
| No | Ramp Width (in) | 46.5 | Yes | Ramp XSlope (%) | 0.5 |

Remove & Replace Entire Ramp.
