Access Compliance Report

Public Rights-of-Way

(Curb Ramps)

Intersection ID: 26251	Main Street: BEVINGTON_PL	Cross Street: CHIPSTEAD_LN	Location: NE
ADA ID: 1FAB3C6C7F4E	Ramp Type: PerpDiag	Initial Pass/Fail: Fail	Overall Compliance: No
		Severity Score: 60

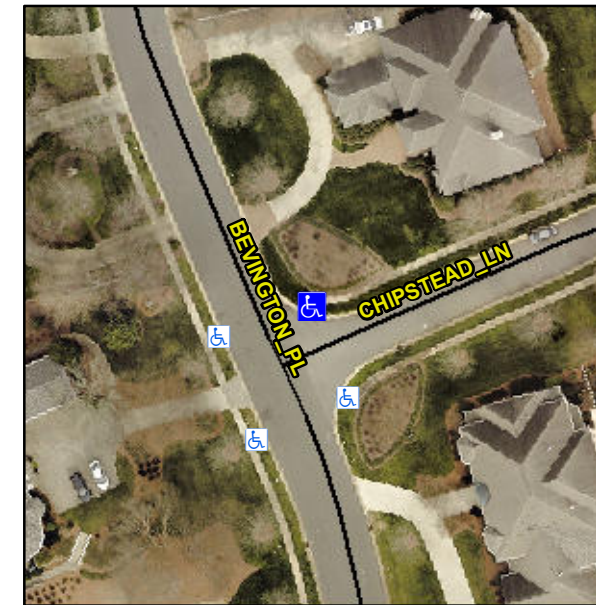
Compliance	Description	Data	Compliance	Description	Data
N/A	Ramp Length (in)	121.0	Yes	Ramp Slope (%)	5.2
No	Ramp Width (in)	25.0	No	Ramp XSlope (%)	8.5
N/A	Flare Type LT	N/A	N/A	Flare Type RT	N/A
N/A	Flare Slope LT (%)	N/A	N/A	Flare Slope RT (%)	N/A
N/A	Flare Traversable LT?	N/A	N/A	Flare Traversable RT?	N/A
N/A	Landing Length (in)	N/A	N/A	DWS Provided?	N/A
N/A	Landing Width (in)	N/A	N/A	DWS Contrast?	N/A
N/A	Landing Slope (%)	N/A	N/A	DWS Length (in)	N/A
N/A	Landing X Slope (%)	N/A	N/A	DWS Full Width?	N/A
N/A	Landing Curb? (Y/N)	N/A	N/A	DWS Offset (in)	N/A
N/A	Shared Landing?	N/A			
N/A	Gutter Ponding?	N/A	N/A	Gutter Slope (%)	N/A
N/A	Gutter Lip Ht (in)	N/A	N/A	Gutter X Slope (%)	N/A
N/A	Painted X Walk1?	No	N/A	Painted X Walk2?	No
	X Walk 1 Direction	To W		X Walk 2 Direction	To SE
N/A	X Walk 1 Width (in)	N/A	N/A	X Walk 2 Width (in)	N/A
	X Walk 1 Slope (%)	2.9		X Walk 2 Slope (%)	1.5
	X Walk 1 X Slope (%)	3.2		X Walk 2 X Slope (%)	2.7

N/A	Ramp inside XWalk1?	N/A	N/A	Ramp inside XWalk2?	N/A
	Road Slope (%)	8.9	N/A	Clear Space?	N/A
	Road X Slope (%)	2.0	N/A	Clear Space to XWalk (in)	N/A
N/A	Any Obstructions?	N/A	N/A	Storm Grate/Utility Hazard?	N/A
	Obstruction Type			Storm Grate/Utility Type	
		N/A			N/A
			Yes	Surface Condition? (G/P)	Good

Possible Solutions:

Remove & Replace Curb Ramp With Two New Directional Ramps or Equivalent.

R304.5.1, R304.5.3
