Access Compliance Report

Public Rights-of-Way (Curb Ramps)

Intersection ID: 30454	Main Street: SHALOM_PARK_DR	Cross Street: PROVIDENCE_RD	Location: SE
ADA ID: 1FAD5397CE15	Ramp Type: BlendTrans2	Initial Pass/Fail: Fail	Overall Compliance: No
		Severity Score: 12.5

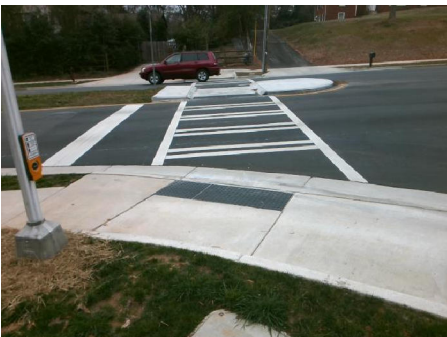
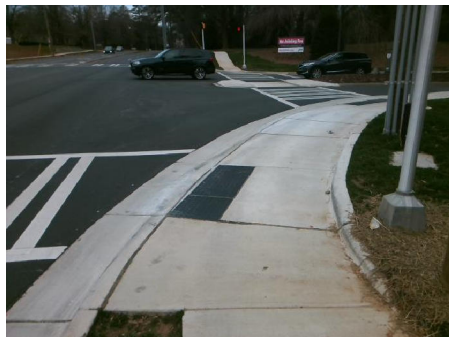
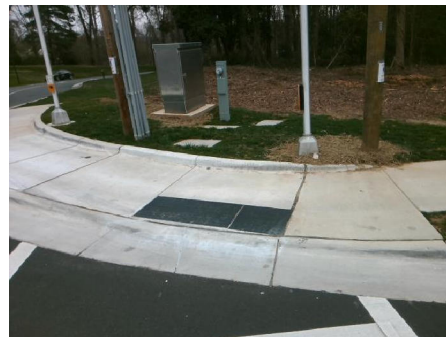
Compliance	Description	Data	Compliance	Description	Data
N/A	Ramp Length (in)	70.0	Yes	BlendTrans Slope (%)	0.5
Yes	Ramp Width (in)	70.0	No	BlendTrans XSlope (%)	5.4
N/A	Flare Type LT	N/A	N/A	Flare Type RT	N/A
N/A	Flare Slope LT (%)	N/A	N/A	Flare Slope RT (%)	N/A
N/A	Flare Traversable LT?	N/A	N/A	Flare Traversable RT?	N/A
N/A	Landing Length (in)	N/A	N/A	DWS Provided?	N/A
N/A	Landing Width (in)	N/A	N/A	DWS Contrast?	N/A
N/A	Landing Slope (%)	N/A	N/A	DWS Length (in)	N/A
N/A	Landing X Slope (%)	N/A	N/A	DWS Full Width?	N/A
N/A	Landing Curb? (Y/N)	N/A	N/A	DWS Offset (in)	N/A
N/A	Shared Landing?	N/A			
N/A	Gutter Ponding?	N/A	N/A	Gutter Slope (%)	N/A
N/A	Gutter Lip Ht (in)	N/A	N/A	Gutter X Slope (%)	N/A
N/A	Painted X Walk1?	Yes	N/A	Painted X Walk2?	N/A
	X Walk 1 Direction	To SW		X Walk 2 Direction	N/A
	X Walk 1 Width (in)	115.0		X Walk 2 Width (in)	N/A
	X Walk 1 Slope (%)	4.1		X Walk 2 Slope (%)	N/A
	X Walk 1 X Slope (%)	4.8		X Walk 2 X Slope (%)	N/A

N/A	Ramp inside XWalk1?	Yes	N/A	Ramp inside XWalk2?	N/A
	Road Slope (%)	4.8		Clear Space?	N/A
	Road X Slope (%)	4.1	N/A	Clear Space to XWalk (in)	N/A
N/A	Any Obstructions?	N/A	N/A	Storm Grate/Utility Hazard?	N/A
	Obstruction Type			Storm Grate/Utility Type	
		N/A			N/A
			Yes	Surface Condition? (G/P)	Good
			N/A	Curb Slope (%)	0.7

Remove & Replace Curb Ramp With Two New Directional Ramps or Equivalent.
