# Access Compliance Report

## Public Rights-of-Way

Intersection ID: 10033070	Main Street: NORTH_COMMUNITY_HOUSE_RD	Cross Street: N/A	Location: SE
ADA ID: 1FAECC958B67	Ramp Type: Perp	Initial Pass/Fail: Fail	Overall Compliance: No
		Severity Score: 8.75	
Codes/Mitigation Info/Possible Solution		Field Measurements/Component Compliance

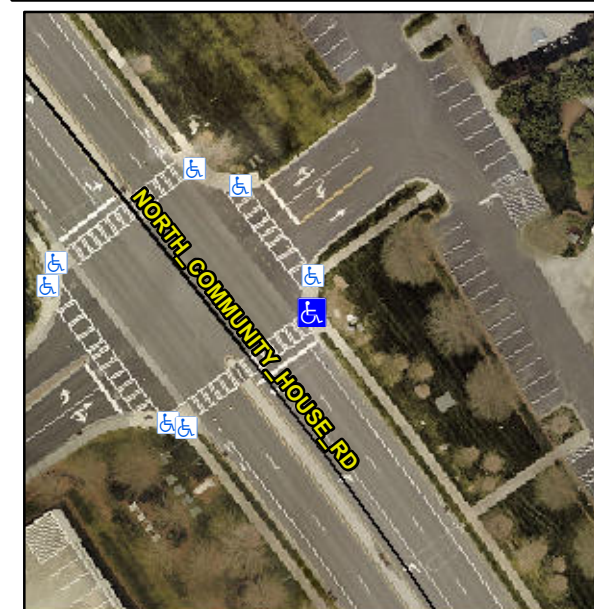
Compliance	Description	Data	Compliance	Description	Data
N/A	Ramp Length (in)	87.5	Yes	Ramp Slope (%)	7.4
No	Ramp Width (in)	46.5	Yes	Ramp XSlope (%)	1.5
N/A	Flare Type LT	N/A	N/A	Flare Type RT	N/A
N/A	Flare Slope LT (%)	N/A	N/A	Flare Slope RT (%)	N/A
N/A	Flare Traversable LT?	N/A	N/A	Flare Traversable RT?	N/A
N/A	Landing Length (in)	N/A	N/A	DWS Provided?	N/A
N/A	Landing Width (in)	N/A	N/A	DWS Contrast?	N/A
N/A	Landing Slope (%)	N/A	N/A	DWS Length (in)	N/A
N/A	Landing X Slope (%)	N/A	N/A	DWS Full Width?	N/A
N/A	Landing Curb? (Y/N)	N/A	N/A	DWS Offset (in)	N/A
N/A	Shared Landing?	N/A			
N/A	Gutter Ponding?	N/A	N/A	Gutter Slope (%)	N/A
N/A	Gutter Lip Ht (in)	N/A	N/A	Gutter X Slope (%)	N/A
N/A	Painted X Walk1?	Yes	N/A	Painted X Walk2?	N/A
	X Walk 1 Direction	To SW		X Walk 2 Direction	N/A
N/A	X Walk 1 Width (in)	127.0	N/A	X Walk 2 Width (in)	N/A
	X Walk 1 Slope (%)	3.1		X Walk 2 Slope (%)	N/A
	X Walk 1 X Slope (%)	1.6		X Walk 2 X Slope (%)	N/A

N/A	Ramp inside XWalk1?	Yes	N/A	Ramp inside XWalk2?	N/A
	Road Slope (%)	N/A	N/A	Clear Space?	N/A
	Road X Slope (%)	N/A	N/A	Clear Space to XWalk (in)	N/A
N/A	Any Obstructions?	N/A	N/A	Storm Grate/Utility Hazard?	N/A
	Obstruction Type			Storm Grate/Utility Type	
		N/A			N/A
			Yes	Surface Condition? (G/P)	Good

Possible Solutions:

**Remove & Replace Entire Ramp.**

**R304.5.1**

Total Cost: \$ 1850.00
