# Access Compliance Report Public Rights-of-Way (Curb Ramps)

Intersection ID: 44871	Main Street: CONLAN_CR	Cross Street: HUFFINES_LN	Location: SW
ADA ID: 1FB9694CF061	Ramp Type: BlendTrans1	Initial Pass/Fail: Fail	Overall Compliance: No Severity Score: 33.75

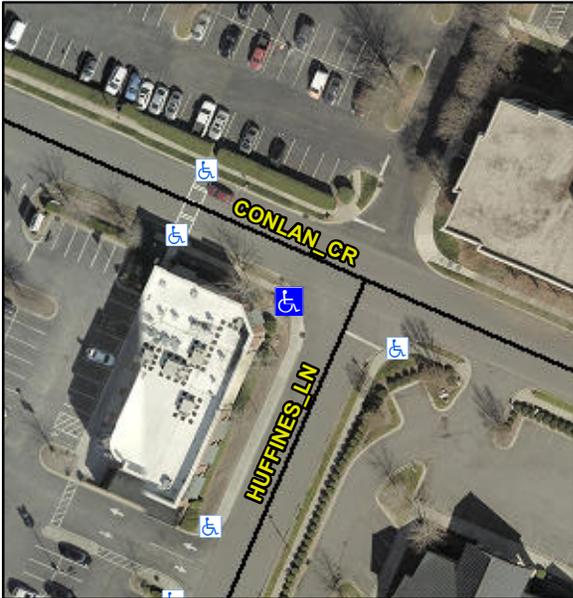
Compliance	Description	Data	Compliance	Description	Data
N/A	Ramp Length (in)	59.0	Yes	BlendTrans Slope (%)	3.3
No	Ramp Width (in)	43.0	No	BlendTrans XSlope (%)	14.2
N/A	Flare Type LT	N/A	N/A	Flare Type RT	N/A
N/A	Flare Slope LT (%)	N/A	N/A	Flare Slope RT (%)	N/A
N/A	Flare Traversable LT?	N/A	N/A	Flare Traversable RT?	N/A
N/A	Landing Length (in)	N/A	N/A	DWS Provided?	N/A
N/A	Landing Width (in)	N/A	N/A	DWS Contrast?	N/A
N/A	Landing Slope (%)	N/A	N/A	DWS Length (in)	N/A
N/A	Landing X Slope (%)	N/A	N/A	DWS Full Width?	N/A
N/A	Landing Curb? (Y/N)	N/A	N/A	DWS Offset (in)	N/A
N/A	Shared Landing?	N/A			
N/A	Gutter Ponding?	N/A	N/A	Gutter Slope (%)	N/A
N/A	Gutter Lip Ht (in)	N/A	N/A	Gutter X Slope (%)	N/A
N/A	Painted X Walk1?	No	N/A	Painted X Walk2?	No
	X Walk 1 Direction	To SE		X Walk 2 Direction	To N
	X Walk 1 Width (in)	N/A		X Walk 2 Width (in)	N/A
	X Walk 1 Slope (%)	4.7		X Walk 2 Slope (%)	0.2
	X Walk 1 X Slope (%)	3.2		X Walk 2 X Slope (%)	2.6

N/A	Ramp inside XWalk1?	N/A	N/A	Ramp inside XWalk2?	N/A
	Road Slope (%)	4.2		Clear Space?	N/A
	Road X Slope (%)	0.2	N/A	Clear Space to XWalk (in)	N/A
N/A	Any Obstructions?	N/A	N/A	Storm Grate/Utility Hazard?	N/A
	Obstruction Type			Storm Grate/Utility Type	
		N/A			N/A
Yes	Surface Condition? (G/P)		Yes		Good
No	Curb Slope (%)		No		13.7

Possible Solutions:  
**Remove & Replace Curb Ramp With Two New Directional Ramps or Equivalent.**

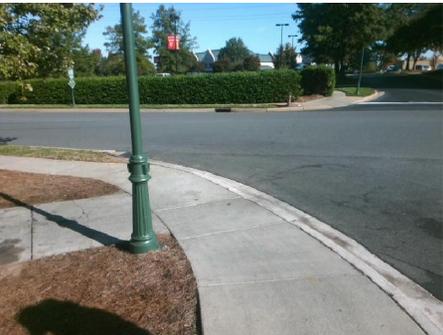
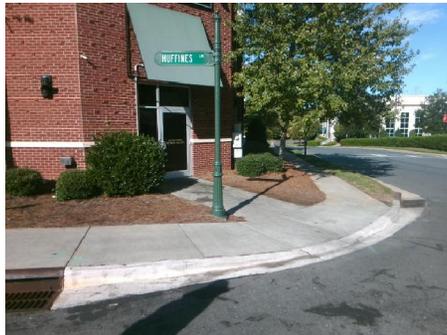
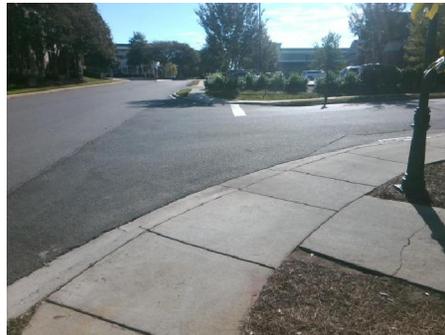
PROW/ADA:  
**Not Found, R304.5.1, R304.5.3**
