Access Compliance Report

Public Rights-of-Way

(Curb Ramps)

Intersection ID: 7852	Main Street: JARMON_CT	Cross Street: SNOW_WHITE_LN	Location: SW
ADA ID: 1FC1CA83D52B	Ramp Type: Perp	Initial Pass/Fail: Fail	Overall Compliance: No
Severity Score: 10			
Codes/Mitigation Info/Possible Solution		Field Measurements/Component Compliance

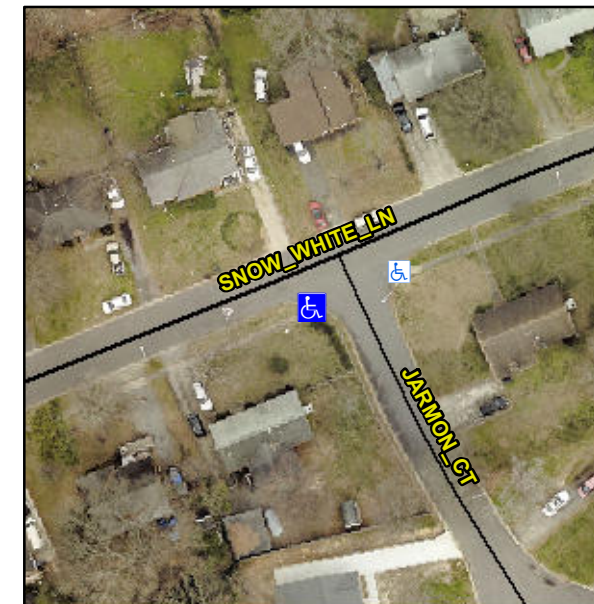
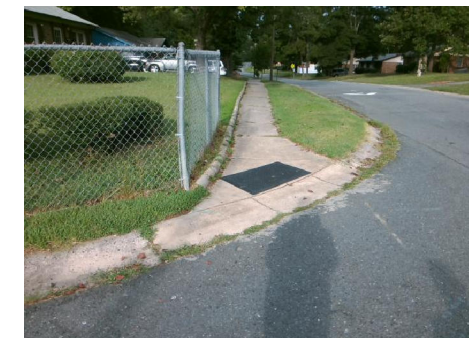
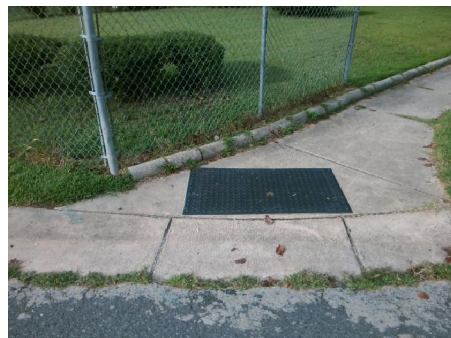
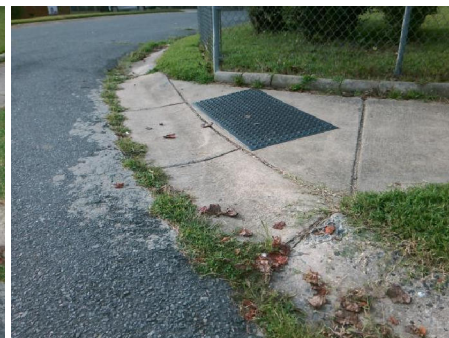
Not Found, R304.5.1, R304.5.3

Compliance	Description	Data	Compliance	Description	Data
N/A	Ramp Length (in)	26.0	Yes	Ramp Slope (%)	5.9
No	Ramp Width (in)	47.0	No	Ramp XSlope (%)	2.4
N/A	Flare Type LT	N/A	N/A	Flare Type RT	N/A
N/A	Flare Slope LT (%)	N/A	N/A	Flare Slope RT (%)	N/A
N/A	Flare Traversable LT?	N/A	N/A	Flare Traversable RT?	N/A
N/A	Landing Length (in)	N/A	N/A	DWS Provided?	N/A
N/A	Landing Width (in)	N/A	N/A	DWS Contrast?	N/A
N/A	Landing Slope (%)	N/A	N/A	DWS Length (in)	N/A
N/A	Landing X Slope (%)	N/A	N/A	DWS Full Width?	N/A
N/A	Landing Curb? (Y/N)	N/A	N/A	DWS Offset (in)	N/A
N/A	Shared Landing?	N/A			
N/A	Gutter Ponding?	N/A	N/A	Gutter Slope (%)	N/A
N/A	Gutter Lip Ht (in)	1.0	N/A	Gutter X Slope (%)	N/A
N/A	Painted X Walk1?	No	N/A	Painted X Walk2?	N/A
	X Walk 1 Direction	To E		X Walk 2 Direction	N/A
N/A	X Walk 1 Width (in)	N/A	N/A	X Walk 2 Width (in)	N/A
	X Walk 1 Slope (%)	1.1		X Walk 2 Slope (%)	N/A
	X Walk 1 X Slope (%)	0.8		X Walk 2 X Slope (%)	N/A

N/A	Ramp inside XWalk1?	N/A	N/A	Ramp inside XWalk2?	N/A
	Road Slope (%)	N/A	N/A	Clear Space?	N/A
	Road X Slope (%)	N/A	N/A	Clear Space to XWalk (in)	N/A
N/A	Any Obstructions?	N/A	N/A	Storm Grate/Utility Hazard?	N/A
	Obstruction Type			Storm Grate/Utility Type	
		N/A			N/A
			Yes	Surface Condition? (G/P)	Good

Remove & Replace Entire Ramp.
