Access Compliance Report

Public Rights-of-Way

(Curb Ramps)

Intersection ID: 5333	Main Street: COMPATIBLE_WY	Cross Street: IBM_DR	Location: SW
ADA ID: 1FCCEF560EEB	Ramp Type: PerpDiag	Initial Pass/Fail: Fail	Overall Compliance: No
		Severity Score: 22.5

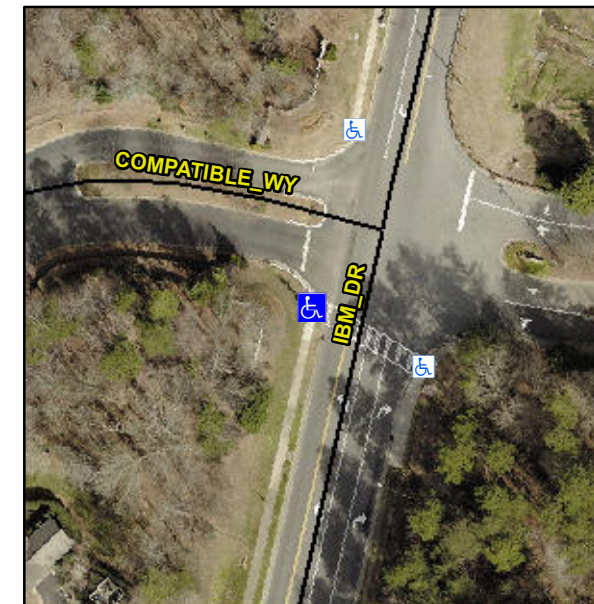
Not Found, R304.5.1, R304.2.2, R304.5.3

Compliance	Description	Data	Compliance	Description	Data
N/A	Ramp Length (in)	39.5	No	Ramp Slope (%)	11.2
No	Ramp Width (in)	47.0	No	Ramp XSlope (%)	4.2
N/A	Flare Type LT	N/A	N/A	Flare Type RT	N/A
N/A	Flare Slope LT (%)	N/A	N/A	Flare Slope RT (%)	N/A
N/A	Flare Traversable LT?	N/A	N/A	Flare Traversable RT?	N/A
N/A	Landing Length (in)	N/A	N/A	DWS Provided?	N/A
N/A	Landing Width (in)	N/A	N/A	DWS Contrast?	N/A
N/A	Landing Slope (%)	N/A	N/A	DWS Length (in)	N/A
N/A	Landing X Slope (%)	N/A	N/A	DWS Full Width?	N/A
N/A	Landing Curb? (Y/N)	N/A	N/A	DWS Offset (in)	N/A
N/A	Shared Landing?	N/A			
N/A	Gutter Ponding?	N/A	N/A	Gutter Slope (%)	N/A
N/A	Gutter Lip Ht (in)	N/A	N/A	Gutter X Slope (%)	N/A
N/A	Painted X Walk1?	Yes	N/A	Painted X Walk2?	No
	X Walk 1 Direction	To SE		X Walk 2 Direction	To N
N/A	X Walk 1 Width (in)	117.0	N/A	X Walk 2 Width (in)	N/A
	X Walk 1 Slope (%)	2.4		X Walk 2 Slope (%)	1.5
	X Walk 1 X Slope (%)	0.2		X Walk 2 X Slope (%)	2.3

N/A	Ramp inside XWalk1?	Yes	N/A	Ramp inside XWalk2?	N/A
	Road Slope (%)	0.6	N/A	Clear Space?	N/A
	Road X Slope (%)	4.3	N/A	Clear Space to XWalk (in)	N/A
N/A	Any Obstructions?	N/A	N/A	Storm Grate/Utility Hazard?	N/A
	Obstruction Type			Storm Grate/Utility Type	
		N/A			N/A
			Yes	Surface Condition? (G/P)	Good

Remove & Replace Curb Ramp With Two New Directional Ramps or Equivalent.
