## **Access Compliance Report Public Rights-of-Way** (Curb Ramps)

Intersection ID: 30265 Main Street: FORTESCUE DR Cross Street: W\_ROCKY\_RIVER\_RD Location: ADA ID: 1FD7E46D3B57 Ramp Type: Perp Initial Pass/Fail: Fail **Overall Compliance: No** Severity Score: 33.75

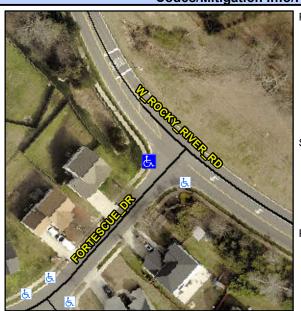
Field Measurements/Component Compliance					
Comp	liance Description	Data	Comp	liance Description	Data
N/A	Ramp Length (in)	44.0	No	Ramp Slope (%)	12.9
No	Ramp Width (in)	38.0	Yes	Ramp XSlope (%)	0.3
N/A	Flare Type LT	N/A	N/A	Flare Type RT	N/A
N/A	Flare Slope LT (%)	N/A	N/A	Flare Slope RT (%)	N/A
N/A	Flare Traversable LT?	N/A	N/A	Flare Traversable RT?	N/A
N/A	Landing Length (in)	N/A	N/A	DWS Provided?	N/A
N/A	Landing Width (in)	N/A	N/A	DWS Contrast?	N/A
N/A	Landing Slope (%)	N/A	N/A	DWS Length (in)	N/A
N/A	Landing X Slope (%)	N/A	N/A	DWS Full Width?	N/A
N/A	Landing Curb? (Y/N)	N/A	N/A	DWS Offset (in)	N/A
N/A	Shared Landing?	N/A			
N/A	Gutter Ponding?	N/A	N/A	Gutter Slope (%)	N/A
N/A	Gutter Lip Ht (in)	N/A	N/A	Gutter X Slope (%)	N/A
N/A	Painted X Walk1?	No	N/A	Painted X Walk2?	N/A
	X Walk 1 Direction	To S		X Walk 2 Direction	N/A
N/A	X Walk 1 Width (in)	N/A	N/A	X Walk 2 Width (in)	N/A
	X Walk 1 Slope (%)	1.0		X Walk 2 Slope (%)	N/A

X Walk 1 X Slope (%)	2.4		X Walk 2 X Slope (%)	N/A
N/A	Ramp inside XWalk1?	N/A	N/A	Ramp inside XWalk2?	N/A
	Road Slope (%)	N/A	N/A	Clear Space?	N/A
	Road X Slope (%)	N/A	N/A	Clear Space to XWalk (in)	N/A
N/A	Any Obstructions?	N/A	N/A	Storm Grate/Utility Hazard?	N/A
	Obstruction Type			Storm Grate/Utility Type	
		N/A			N/A
			Yes	Surface Condition? (G/P)	Good

**FORTESCUE DR** Street 1 Name Stop Condition-Street 2 StopSign Street 2 Name N/A Stop Condition-Street 1 N/A Possible Solutions: Remove & Replace Entire Ramp. Surveyor Notes: N/A PROW/ADA: Not Found, R304.5.1, R304.2.2
