Access Compliance Report

Public Rights-of-Way

(Curb Ramps)

Intersection ID: N/A	Main Street: TROJAN_DR	Cross Street: OUTLETS_BV	Location: S
ADA ID: 1FD8363BCD95	Ramp Type: PerpDiag	Initial Pass/Fail: Fail	Overall Compliance: No
		Severity Score: 8.75

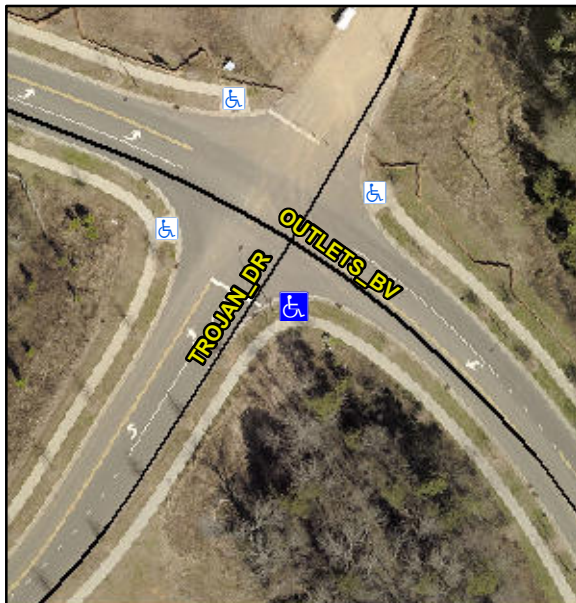
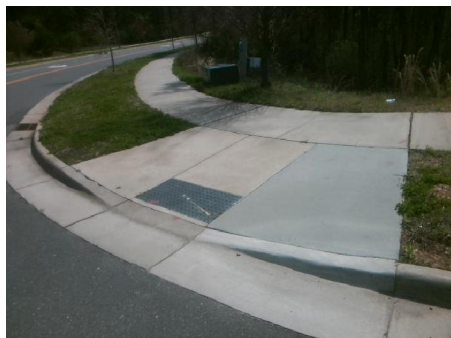
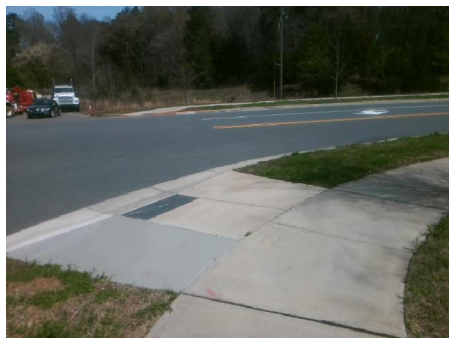
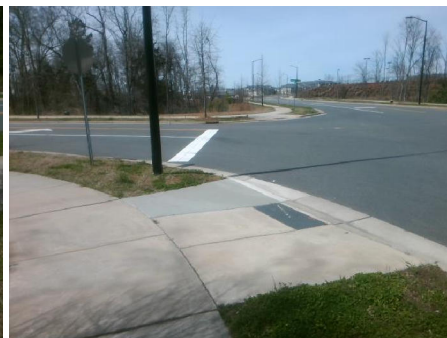
Not Found, R304.5.1

Compliance	Description	Data	Compliance	Description	Data
N/A	Ramp Length (in)	95.0	Yes	Ramp Slope (%)	6.8
No	Ramp Width (in)	47.0	Yes	Ramp XSlope (%)	1.2
N/A	Flare Type LT	N/A	N/A	Flare Type RT	N/A
N/A	Flare Slope LT (%)	N/A	N/A	Flare Slope RT (%)	N/A
N/A	Flare Traversable LT?	N/A	N/A	Flare Traversable RT?	N/A
N/A	Landing Length (in)	N/A	N/A	DWS Provided?	N/A
N/A	Landing Width (in)	N/A	N/A	DWS Contrast?	N/A
N/A	Landing Slope (%)	N/A	N/A	DWS Length (in)	N/A
N/A	Landing X Slope (%)	N/A	N/A	DWS Full Width?	N/A
N/A	Landing Curb? (Y/N)	N/A	N/A	DWS Offset (in)	N/A
N/A	Shared Landing?	N/A			
N/A	Gutter Ponding?	N/A	N/A	Gutter Slope (%)	N/A
N/A	Gutter Lip Ht (in)	N/A	N/A	Gutter X Slope (%)	N/A
N/A	Painted X Walk1?	No	N/A	Painted X Walk2?	No
	X Walk 1 Direction	To NE		X Walk 2 Direction	To NW
N/A	X Walk 1 Width (in)	N/A	N/A	X Walk 2 Width (in)	N/A
	X Walk 1 Slope (%)	1.4		X Walk 2 Slope (%)	1.6
	X Walk 1 X Slope (%)	1.5		X Walk 2 X Slope (%)	0.4

N/A	Ramp inside XWalk1?	N/A	N/A	Ramp inside XWalk2?	N/A
	Road Slope (%)	2.9	N/A	Clear Space?	N/A
	Road X Slope (%)	2.6	N/A	Clear Space to XWalk (in)	N/A
N/A	Any Obstructions?	N/A	N/A	Storm Grate/Utility Hazard?	N/A
	Obstruction Type			Storm Grate/Utility Type	
		N/A			N/A
			Yes	Surface Condition? (G/P)	Good

Remove & Replace Curb Ramp With Two New Directional Ramps or Equivalent.
