Access Compliance Report

Public Rights-of-Way

(Curb Ramps)

Intersection ID: 10040846	Main Street: WAKEFIELD_DR	Cross Street: N/A	Location: E
ADA ID: 1FDD5B962334	Ramp Type: Perp	Initial Pass/Fail: Fail	Overall Compliance: No
Severity Score: 26.25			
Codes/Mitigation Info/Possible Solution		Field Measurements/Component Compliance

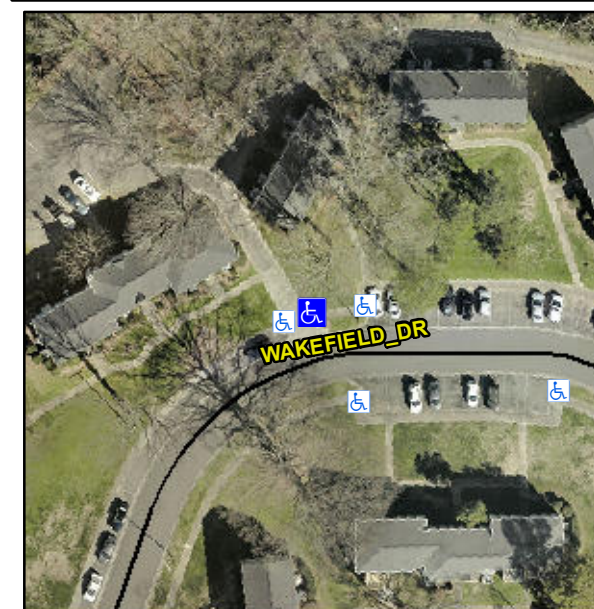
Not Found, R304.2.2, R304.5.3

Compliance	Description	Data	Compliance	Description	Data
N/A	Ramp Length (in)	82.0	No	Ramp Slope (%)	13.4
Yes	Ramp Width (in)	48.0	No	Ramp XSlope (%)	4.2
N/A	Flare Type LT	N/A	N/A	Flare Type RT	N/A
N/A	Flare Slope LT (%)	N/A	N/A	Flare Slope RT (%)	N/A
N/A	Flare Traversable LT?	N/A	N/A	Flare Traversable RT?	N/A
N/A	Landing Length (in)	N/A	N/A	DWS Provided?	N/A
N/A	Landing Width (in)	N/A	N/A	DWS Contrast?	N/A
N/A	Landing Slope (%)	N/A	N/A	DWS Length (in)	N/A
N/A	Landing X Slope (%)	N/A	N/A	DWS Full Width?	N/A
N/A	Landing Curb? (Y/N)	N/A	N/A	DWS Offset (in)	N/A
N/A	Shared Landing?	N/A			
N/A	Gutter Ponding?	N/A	N/A	Gutter Slope (%)	N/A
N/A	Gutter Lip Ht (in)	N/A	N/A	Gutter X Slope (%)	N/A
N/A	Painted X Walk1?	No	N/A	Painted X Walk2?	N/A
	X Walk 1 Direction	To W		X Walk 2 Direction	N/A
N/A	X Walk 1 Width (in)	N/A	N/A	X Walk 2 Width (in)	N/A
	X Walk 1 Slope (%)	2.7		X Walk 2 Slope (%)	N/A
	X Walk 1 X Slope (%)	2.7		X Walk 2 X Slope (%)	N/A

Remove & Replace Entire Ramp.
