# Access Compliance Report

## Public Rights-of-Way

### (Curb Ramps)

| ADA ID: 1FEA55B78131 | Ramp Type: Perp | Initial Pass/Fail: Pass | Overall Compliance: No |

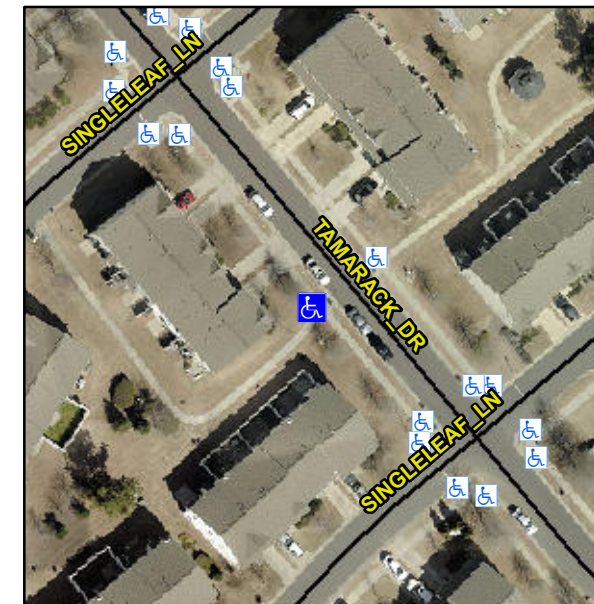
**R304.2.1, R304.2.2-Perp, R304.3.2-  
Para, R304.5.3**

| Compliance | Description | Data | Compliance | Description | Data |
|---|---|---|---|---|---|
| No | Landing Length (in) | 47.5 | Yes | DWS Provided? | Yes |
| No | Landing Slope (%) | 3.2 | Yes | DWS Length (in) | 24.5 |
| Yes | Gutter Lip Ht (in) | 0.0 | No | Gutter X Slope (%) | 3.3 |

**Remove & Replace Landing.  
Remove & Replace Gutter.**
