Access Compliance Report

Public Rights-of-Way

(Curb Ramps)

Intersection ID: 42923	Main Street: BRAY_DR	Cross Street: LIFFORD_DR	Location:	N
ADA ID: 1FEBDBCE8AAA	Ramp Type: PerpDiag	Initial Pass/Fail: Fail	Overall Compliance: No	Severity Score: 17.5
Codes/Mitigation Info/Possible Solution		Field Measurements/Component Compliance

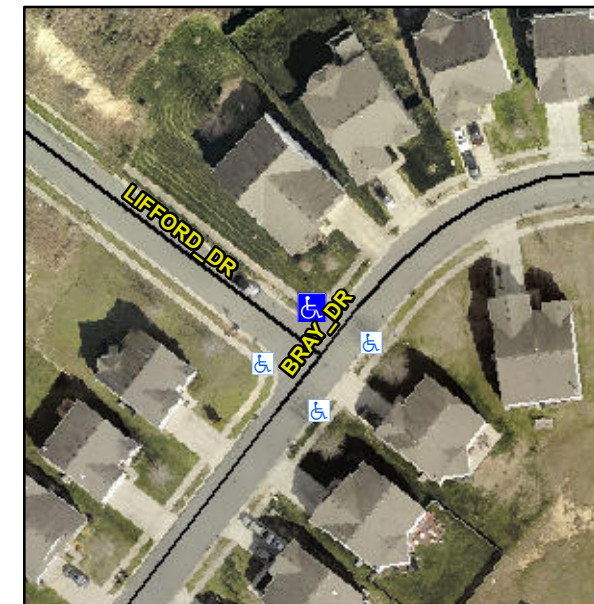
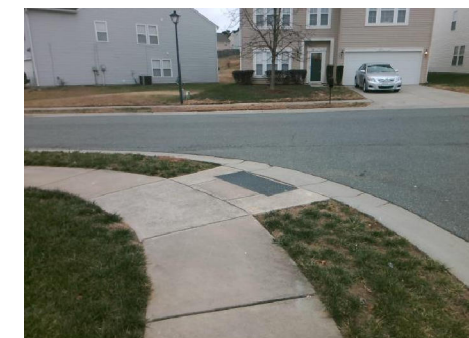
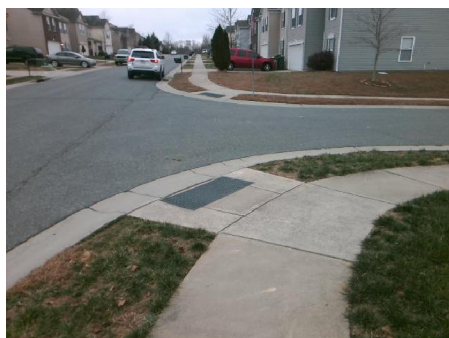
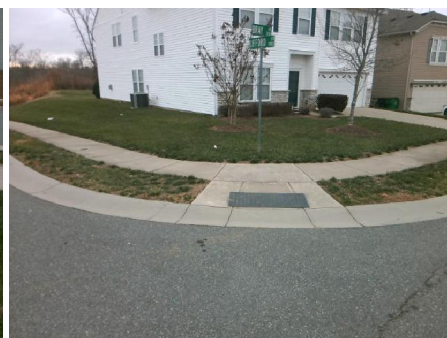
Not Found, R304.5.1

Compliance	Description	Data	Compliance	Description	Data
N/A	Ramp Length (in)	48.0	Yes	Ramp Slope (%)	6.0
No	Ramp Width (in)	32.0	Yes	Ramp XSlope (%)	0.9
N/A	Flare Type LT	N/A	N/A	Flare Type RT	N/A
N/A	Flare Slope LT (%)	N/A	N/A	Flare Slope RT (%)	N/A
N/A	Flare Traversable LT?	N/A	N/A	Flare Traversable RT?	N/A
N/A	Landing Length (in)	N/A	N/A	DWS Provided?	N/A
N/A	Landing Width (in)	N/A	N/A	DWS Contrast?	N/A
N/A	Landing Slope (%)	N/A	N/A	DWS Length (in)	N/A
N/A	Landing X Slope (%)	N/A	N/A	DWS Full Width?	N/A
N/A	Landing Curb? (Y/N)	N/A	N/A	DWS Offset (in)	N/A
N/A	Shared Landing?	N/A			
N/A	Gutter Ponding?	N/A	N/A	Gutter Slope (%)	N/A
N/A	Gutter Lip Ht (in)	N/A	N/A	Gutter X Slope (%)	N/A
N/A	Painted X Walk1?	No	N/A	Painted X Walk2?	No
	X Walk 1 Direction	To SW		X Walk 2 Direction	To SE
N/A	X Walk 1 Width (in)	N/A	N/A	X Walk 2 Width (in)	N/A
	X Walk 1 Slope (%)	2.7		X Walk 2 Slope (%)	2.4
	X Walk 1 X Slope (%)	1.8		X Walk 2 X Slope (%)	2.6

N/A	Ramp inside XWalk1?	N/A	N/A	Ramp inside XWalk2?	N/A
	Road Slope (%)	1.0	N/A	Clear Space?	N/A
	Road X Slope (%)	3.0	N/A	Clear Space to XWalk (in)	N/A
N/A	Any Obstructions?	N/A	N/A	Storm Grate/Utility Hazard?	N/A
	Obstruction Type			Storm Grate/Utility Type	
		N/A			N/A
			Yes	Surface Condition? (G/P)	Good

Remove & Replace Curb Ramp With Two New Directional Ramps or Equivalent.
