# Access Compliance Report

## Public Rights-of-Way

### (Curb Ramps)

Intersection ID: 19457	Main Street: S_TRYON_ST	Cross Street: YORKDALE_DR	Location: SW
ADA ID: 1FEF6C150F9B	Ramp Type: PerpDiag	Initial Pass/Fail: Fail	Overall Compliance: No
		Severity Score: 10

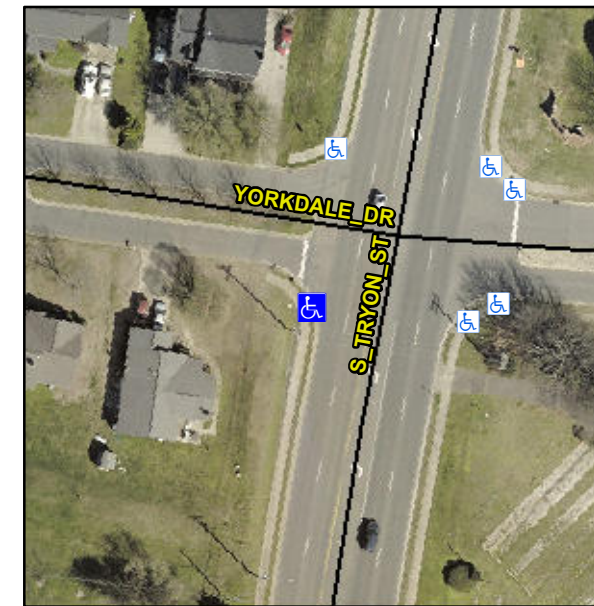
**Not Found, R304.5.1, R304.5.3**

Compliance	Description	Data	Compliance	Description	Data
N/A	Ramp Length (in)	88.0	Yes	Ramp Slope (%)	7.8
No	Ramp Width (in)	43.0	No	Ramp XSlope (%)	3.7
N/A	Flare Type LT	N/A	N/A	Flare Type RT	N/A
N/A	Flare Slope LT (%)	N/A	N/A	Flare Slope RT (%)	N/A
N/A	Flare Traversable LT?	N/A	N/A	Flare Traversable RT?	N/A
N/A	Landing Length (in)	N/A	N/A	DWS Provided?	N/A
N/A	Landing Width (in)	N/A	N/A	DWS Contrast?	N/A
N/A	Landing Slope (%)	N/A	N/A	DWS Length (in)	N/A
N/A	Landing X Slope (%)	N/A	N/A	DWS Full Width?	N/A
N/A	Landing Curb? (Y/N)	N/A	N/A	DWS Offset (in)	N/A
N/A	Shared Landing?	N/A			
N/A	Gutter Ponding?	N/A	N/A	Gutter Slope (%)	N/A
N/A	Gutter Lip Ht (in)	N/A	N/A	Gutter X Slope (%)	N/A
N/A	Painted X Walk1?	No	N/A	Painted X Walk2?	No
	X Walk 1 Direction	To E		X Walk 2 Direction	To N
N/A	X Walk 1 Width (in)	N/A	N/A	X Walk 2 Width (in)	N/A
	X Walk 1 Slope (%)	2.7		X Walk 2 Slope (%)	4.4
	X Walk 1 X Slope (%)	2.6		X Walk 2 X Slope (%)	1.9

N/A	Ramp inside XWalk1?	N/A	N/A	Ramp inside XWalk2?	N/A
	Road Slope (%)	2.5	N/A	Clear Space?	N/A
	Road X Slope (%)	2.5	N/A	Clear Space to XWalk (in)	N/A
N/A	Any Obstructions?	N/A	N/A	Storm Grate/Utility Hazard?	N/A
	Obstruction Type			Storm Grate/Utility Type	
		N/A			N/A
			Yes	Surface Condition? (G/P)	Good

**Remove & Replace Curb Ramp With Two New Directional Ramps or Equivalent.**
