Access Compliance Report

Public Rights-of-Way

(Curb Ramps)

Intersection ID: 10276	Main Street: ASHLEY_RD	Cross Street: TUCKASEEGEE_RD	Location: SE
ADA ID: 1FF0C6DFE1B9	Ramp Type: Perp	Initial Pass/Fail: Fail	Overall Compliance: No
		Severity Score: 10

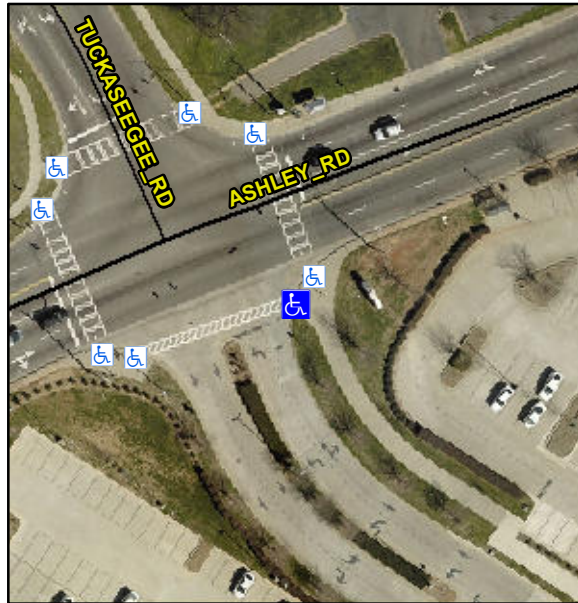
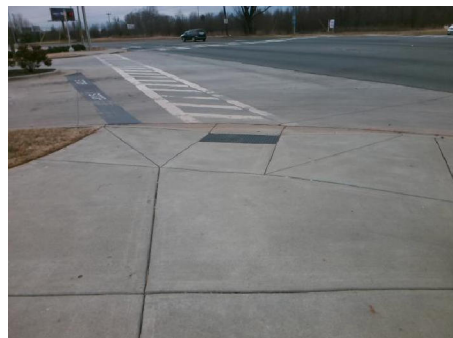
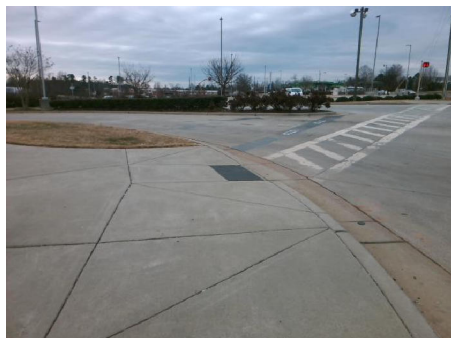
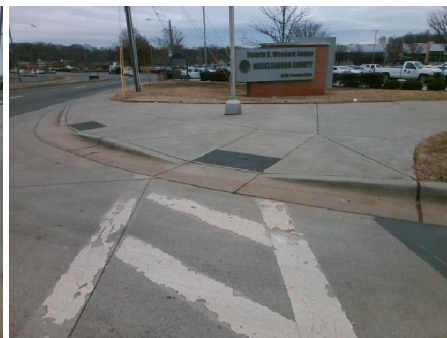
Compliance	Description	Data	Compliance	Description	Data
N/A	Ramp Length (in)	84.0	Yes	Ramp Slope (%)	5.7
No	Ramp Width (in)	47.5	No	Ramp XSlope (%)	3.4
N/A	Flare Type LT	N/A	N/A	Flare Type RT	N/A
N/A	Flare Slope LT (%)	N/A	N/A	Flare Slope RT (%)	N/A
N/A	Flare Traversable LT?	N/A	N/A	Flare Traversable RT?	N/A
N/A	Landing Length (in)	N/A	N/A	DWS Provided?	N/A
N/A	Landing Width (in)	N/A	N/A	DWS Contrast?	N/A
N/A	Landing Slope (%)	N/A	N/A	DWS Length (in)	N/A
N/A	Landing X Slope (%)	N/A	N/A	DWS Full Width?	N/A
N/A	Landing Curb? (Y/N)	N/A	N/A	DWS Offset (in)	N/A
N/A	Shared Landing?	N/A			
N/A	Gutter Ponding?	N/A	N/A	Gutter Slope (%)	N/A
N/A	Gutter Lip Ht (in)	N/A	N/A	Gutter X Slope (%)	N/A
N/A	Painted X Walk1?	Yes	N/A	Painted X Walk2?	N/A
	X Walk 1 Direction	To W		X Walk 2 Direction	N/A
N/A	X Walk 1 Width (in)	51.0	N/A	X Walk 2 Width (in)	N/A
	X Walk 1 Slope (%)	2.2		X Walk 2 Slope (%)	N/A
	X Walk 1 X Slope (%)	0.7		X Walk 2 X Slope (%)	N/A

N/A	Ramp inside XWalk1?	Yes	N/A	Ramp inside XWalk2?	N/A
	Road Slope (%)	N/A	N/A	Clear Space?	N/A
	Road X Slope (%)	N/A	N/A	Clear Space to XWalk (in)	N/A
N/A	Any Obstructions?	N/A	N/A	Storm Grate/Utility Hazard?	N/A
	Obstruction Type			Storm Grate/Utility Type	
		N/A			N/A
		Yes		Surface Condition? (G/P)	Good

Remove & Replace Entire Ramp.

R304.5.1, R304.5.3
