Access Compliance Report

Public Rights-of-Way

(Curb Ramps)

Intersection ID: N/A	Main Street: WOODFOX_DR	Cross Street: BURNING_TREE_DR	Location: SE
ADA ID: 1FF7AE0FAFF3	Ramp Type: Directional1	Initial Pass/Fail: Fail	Overall Compliance: No
Severity Score: 12.5			
Codes/Mitigation Info/Possible Solution		Field Measurements/Component Compliance

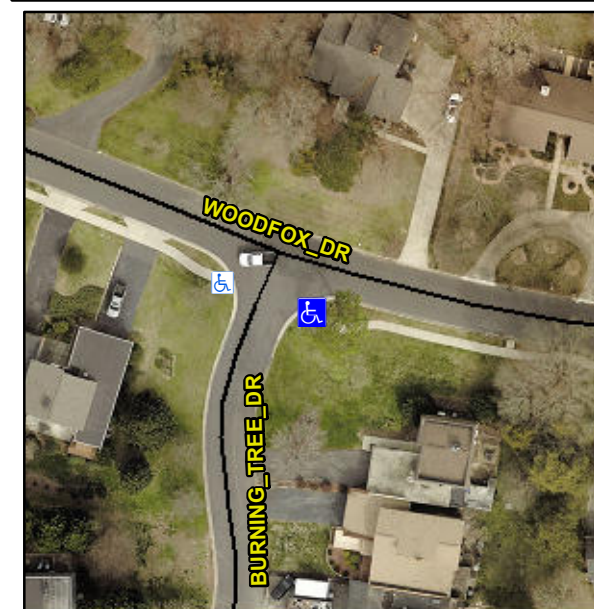
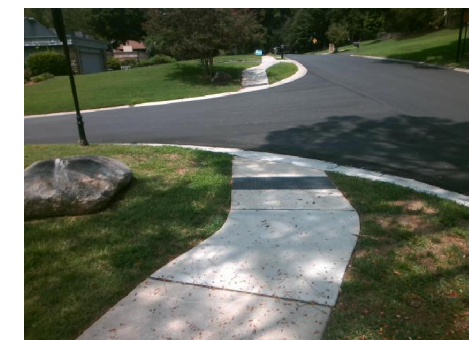
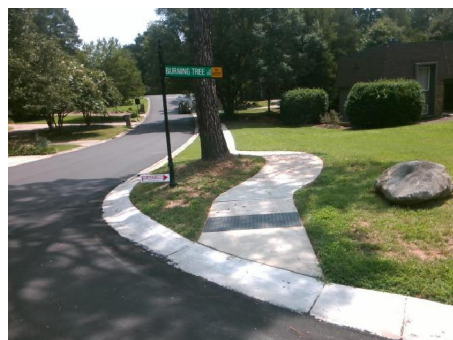
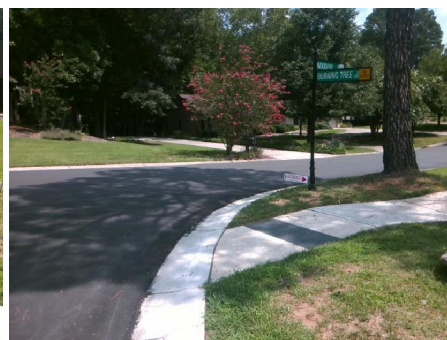
Compliance	Description	Data	Compliance	Description	Data
N/A	Ramp Length (in)	71.0	N/A	Grade Break?	N/A
Yes	Ramp Width (in)	60.0	N/A	Grade Break Slope (%)	0.0
Yes	Ramp Slope (%)	1.3	N/A	Grade Break XSlope (%)	0.0
No	Ramp XSlope (%)	5.6			
N/A	Flare Type LT	N/A	N/A	Flare Type RT	N/A
N/A	Flare Slope LT (%)	N/A	N/A	Flare Slope RT (%)	0.0
N/A	Flare Traversable LT?	N/A	N/A	Flare Traversable RT?	N/A
N/A	Landing Length (in)	0.0	N/A	DWS Provided?	N/A
N/A	Landing Width (in)	0.0	N/A	DWS Contrast?	N/A
N/A	Landing Slope (%)	0.0	N/A	DWS Length (in)	N/A
N/A	Landing X Slope (%)	0.0	N/A	DWS Full Width?	N/A
N/A	Landing Curb? (Y/N)	N/A	N/A	DWS Offset LT (in)	N/A
N/A	Shared Landing?	N/A	N/A	DWS Offset RT (in)	N/A
N/A	Gutter Ponding?	0.0	N/A	Gutter Slope (%)	N/A
N/A	Gutter Lip Ht (in)	0.0	N/A	Gutter X Slope (%)	N/A
N/A	Painted X Walk1?	No		Road Slope (%)	7.7
	X Walk 1 Direction	To W		Road X Slope (%)	5.0
	X Walk 1 Width (in)	N/A		Clear Space?	N/A

X Walk 1 Slope (%)	7.7	N/A	Clear Space to XWalk (in)	N/A
	X Walk 1 X Slope (%)	5.0	N/A	Storm Grate/Utility Hazard?	N/A
N/A	Ramp inside XWalk1?	N/A		Storm Grate/Utility Type	
N/A	Any Obstructions?	N/A			N/A
	Obstruction Type		Yes	Surface Condition? (G/P)	Good
			N/A	Curb Slope (%)	9.7

Remove & Replace Entire Ramp.
