Access Compliance Report

Public Rights-of-Way

(Curb Ramps)

Intersection ID: 15360	Main Street: NEW_BERN_ST	Cross Street: RAIL_CROSSING_LN	Location: NE
ADA ID: 1FFDDFBE255D	Ramp Type: Perp	Initial Pass/Fail: Fail	Overall Compliance: No
Severity Score: 12.5			
Codes/Mitigation Info/Possible Solution		Field Measurements/Component Compliance

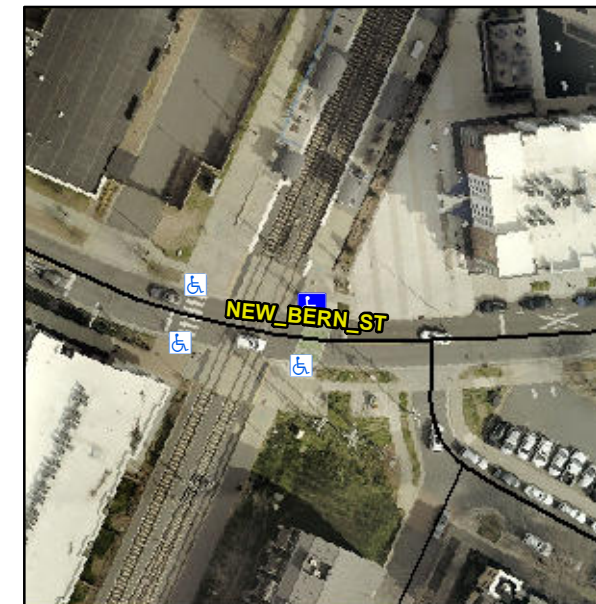
Not Found, R304.2.2

Compliance	Description	Data	Compliance	Description	Data
N/A	Ramp Length (in)	72.0	No	Ramp Slope (%)	8.9
Yes	Ramp Width (in)	156.0	Yes	Ramp XSlope (%)	1.6
N/A	Flare Type LT	N/A	N/A	Flare Type RT	N/A
N/A	Flare Slope LT (%)	N/A	N/A	Flare Slope RT (%)	N/A
N/A	Flare Traversable LT?	N/A	N/A	Flare Traversable RT?	N/A
N/A	Landing Length (in)	N/A	N/A	DWS Provided?	N/A
N/A	Landing Width (in)	N/A	N/A	DWS Contrast?	N/A
N/A	Landing Slope (%)	N/A	N/A	DWS Length (in)	N/A
N/A	Landing X Slope (%)	N/A	N/A	DWS Full Width?	N/A
N/A	Landing Curb? (Y/N)	N/A	N/A	DWS Offset (in)	N/A
N/A	Shared Landing?	N/A			
N/A	Gutter Ponding?	N/A	N/A	Gutter Slope (%)	N/A
N/A	Gutter Lip Ht (in)	N/A	N/A	Gutter X Slope (%)	N/A
N/A	Painted X Walk1?	Yes	N/A	Painted X Walk2?	N/A
	X Walk 1 Direction	To SW		X Walk 2 Direction	N/A
N/A	X Walk 1 Width (in)	156.0	N/A	X Walk 2 Width (in)	N/A
	X Walk 1 Slope (%)	1.6		X Walk 2 Slope (%)	N/A
	X Walk 1 X Slope (%)	1.7		X Walk 2 X Slope (%)	N/A

N/A	Ramp inside XWalk1?	Yes	N/A	Ramp inside XWalk2?	N/A
	Road Slope (%)	N/A	N/A	Clear Space?	N/A
	Road X Slope (%)	N/A	N/A	Clear Space to XWalk (in)	N/A
N/A	Any Obstructions?	N/A	N/A	Storm Grate/Utility Hazard?	N/A
	Obstruction Type			Storm Grate/Utility Type	
		N/A			N/A
		Yes		Surface Condition? (G/P)	Good

Possible Solutions:

Remove & Replace Entire Ramp.

Total Cost: \$ 1850.00
