Access Compliance Report

Public Rights-of-Way

(Curb Ramps)

Intersection ID: 5889	Main Street: UNIVERSITY_CITY_BV	Cross Street: SUTHER_RD	Location: SE
ADA ID: 20110262E758	Ramp Type: Perp	Initial Pass/Fail: Pass	Overall Compliance: No
Codes/Mitigation Info/Possible Solution			Severity Score: 10
			Field Measurements/Component Compliance

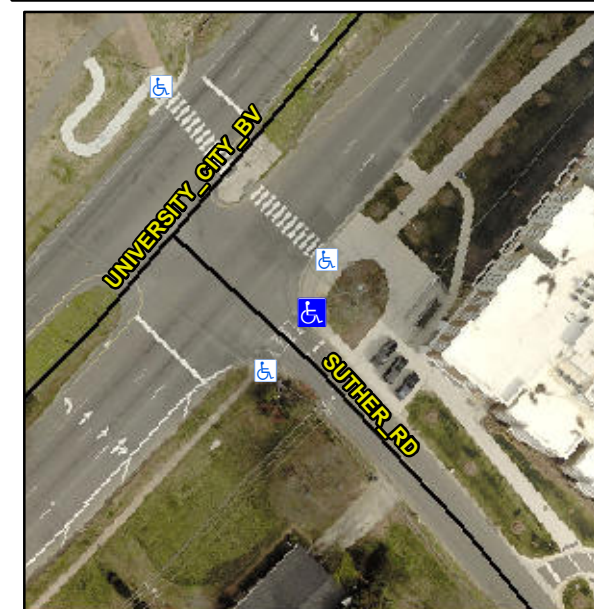
R304.2.1, R304.2.2-Perp, R304.3.2-Para, R304.5.3, R305.2

Compliance	Description	Data	Compliance	Description	Data
N/A	Ramp Length (in)	82.0	Yes	Ramp Slope (%)	6.8
Yes	Ramp Width (in)	48.0	Yes	Ramp XSlope (%)	1.2
N/A	Flare Type LT	Sloped	N/A	Flare Type RT	N/A
N/A	Flare Slope LT (%)	5.1	Yes	Flare Slope RT (%)	8.3
N/A	Flare Traversable LT?	Yes	N/A	Flare Traversable RT?	Yes
No	Landing Length (in)	N/A	Yes	DWS Provided?	Yes
No	Landing Width (in)	N/A	Yes	DWS Contrast?	Yes
No	Landing Slope (%)	N/A	Yes	DWS Length (in)	24.0
No	Landing X Slope (%)	N/A	Yes	DWS Full Width?	Yes
N/A	Landing Curb? (Y/N)	No	No	DWS Offset (in)	5.0
N/A	Shared Landing?	No			
Yes	Gutter Ponding?	No	Yes	Gutter Slope (%)	0.0
Yes	Gutter Lip Ht (in)	0.0	Yes	Gutter X Slope (%)	2.0
N/A	Painted X Walk1?	Yes	N/A	Painted X Walk2?	N/A
	X Walk 1 Direction	To SW		X Walk 2 Direction	N/A
N/A	X Walk 1 Width (in)	104.0	N/A	X Walk 2 Width (in)	N/A
	X Walk 1 Slope (%)	1.1		X Walk 2 Slope (%)	N/A
	X Walk 1 X Slope (%)	3.5		X Walk 2 X Slope (%)	N/A

Yes	Ramp inside XWalk1?	Yes	N/A	Ramp inside XWalk2?	N/A
	Road Slope (%)	N/A	N/A	Clear Space?	Yes
	Road X Slope (%)	N/A	N/A	Clear Space to XWalk (in)	N/A
Yes	Any Obstructions?	No	Yes	Storm Grate/Utility Hazard?	No
	Obstruction Type			Storm Grate/Utility Type	
		N/A			N/A
			Yes	Surface Condition? (G/P)	Good

Possible Solutions:

Remove & Replace Entire Ramp.
