Access Compliance Report

Public Rights-of-Way

(Curb Ramps)

Intersection ID: 8199	Main Street: HOVIS_RD	Cross Street: INTERURBAN_AV	Location: SW
ADA ID: 2016F5E1F5BA	Ramp Type: Para	Initial Pass/Fail: Fail	Overall Compliance: No
			Severity Score: 13.75

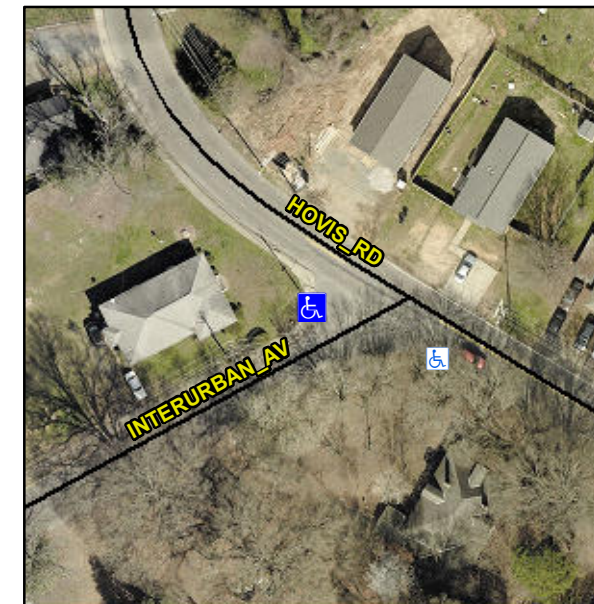
Compliance	Description	Data	Compliance	Description	Data
N/A	Ramp Length LT (in)	49.5	N/A	Ramp Length RT (in)	87.0
Yes	Ramp Width LT (in)	59.0	Yes	Ramp Width RT (in)	59.0
No	Ramp Slope LT (%)	8.6	No	Ramp Slope RT (%)	10.2
Yes	Ramp XSlope LT (%)	1.4	No	Ramp XSlope RT (%)	2.5
N/A	Landing Length (in)	N/A	N/A	DWS Provided?	N/A
N/A	Landing Width (in)	N/A	N/A	DWS Contrast?	N/A
N/A	Landing Slope (%)	N/A	N/A	DWS Length (in)	N/A
N/A	Landing X Slope (%)	N/A	N/A	DWS Full Width?	N/A
N/A	Landing Curb? (Y/N)	N/A	N/A	DWS Offset (in)	N/A
N/A	Shared Landing?	N/A			
N/A	Gutter Ponding?	N/A	N/A	Gutter Slope (%)	N/A
N/A	Gutter Lip Ht (in)	N/A	N/A	Gutter X Slope (%)	N/A
N/A	Painted X Walk1?	No	N/A	Painted X Walk2?	N/A
	X Walk 1 Direction	To NE		X Walk 2 Direction	N/A
N/A	X Walk 1 Width (in)	N/A	N/A	X Walk 2 Width (in)	N/A
	X Walk 1 Slope (%)	0.6		X Walk 2 Slope (%)	N/A
	X Walk 1 X Slope (%)	0.9		X Walk 2 X Slope (%)	N/A
N/A	Ramp inside XWalk1?	N/A	N/A	Ramp inside XWalk2?	N/A

Road Slope (%)	N/A	N/A	Clear Space?	N/A
	Road X Slope (%)	N/A	N/A	Clear Space to XWalk (in)	N/A
N/A	Any Obstructions?	N/A	N/A	Storm Grate/Utility Hazard?	N/A
	Obstruction Type			Storm Grate/Utility Type	
		N/A			N/A
			Yes	Surface Condition? (G/P)	Good
			N/A	Curb Slope (%)	6.5

Remove & Replace Entire Ramp.

R304.3.2, R304.5.3
