Access Compliance Report

Public Rights-of-Way

(Curb Ramps)

Intersection ID: 10289	Main Street: COMMERCIAL_AV	Cross Street: EASTWAY_DR	Location: SW
ADA ID: 201A1C87C552	Ramp Type: BlendTrans1	Initial Pass/Fail: Fail	Overall Compliance: No
Severity Score: 1.25			
Codes/Mitigation Info/Possible Solution		Field Measurements/Component Compliance

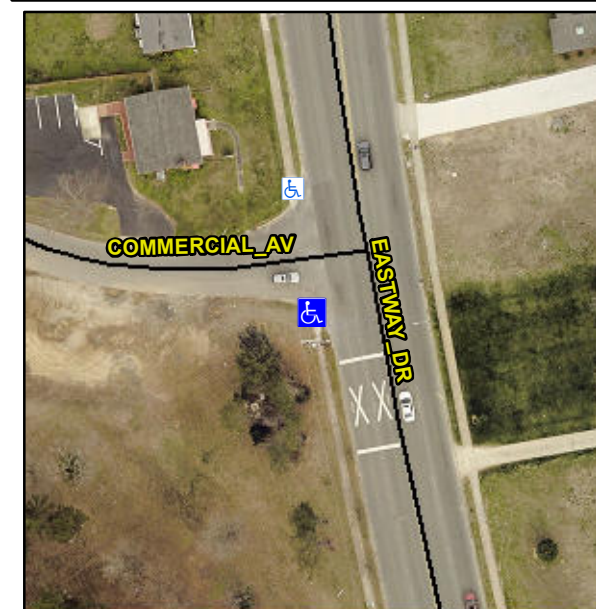
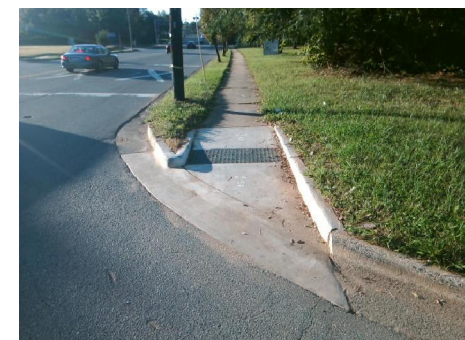
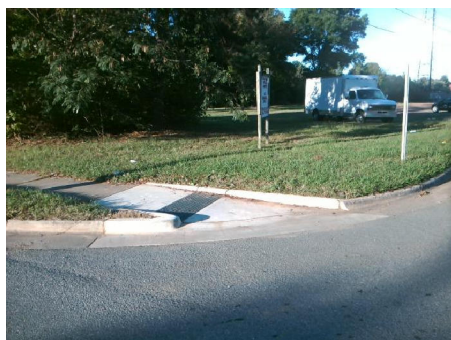
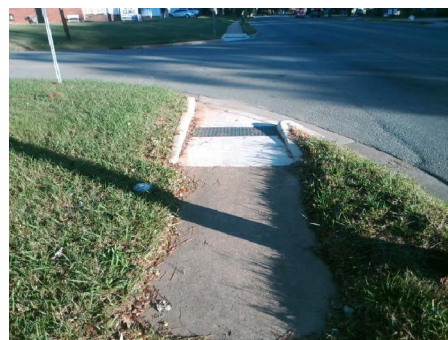
Compliance	Description	Data	Compliance	Description	Data
N/A	Ramp Length (in)	50.0	Yes	BlendTrans Slope (%)	3.3
Yes	Ramp Width (in)	58.0	No	BlendTrans XSlope (%)	3.0
N/A	Flare Type LT	N/A	N/A	Flare Type RT	N/A
N/A	Flare Slope LT (%)	N/A	N/A	Flare Slope RT (%)	N/A
N/A	Flare Traversable LT?	N/A	N/A	Flare Traversable RT?	N/A
N/A	Landing Length (in)	N/A	N/A	DWS Provided?	N/A
N/A	Landing Width (in)	N/A	N/A	DWS Contrast?	N/A
N/A	Landing Slope (%)	N/A	N/A	DWS Length (in)	N/A
N/A	Landing X Slope (%)	N/A	N/A	DWS Full Width?	N/A
N/A	Landing Curb? (Y/N)	N/A	N/A	DWS Offset (in)	N/A
N/A	Shared Landing?	N/A			
N/A	Gutter Ponding?	N/A	N/A	Gutter Slope (%)	N/A
N/A	Gutter Lip Ht (in)	N/A	N/A	Gutter X Slope (%)	N/A
N/A	Painted X Walk1?	No	N/A	Painted X Walk2?	N/A
	X Walk 1 Direction	To N		X Walk 2 Direction	N/A
	X Walk 1 Width (in)	N/A		X Walk 2 Width (in)	N/A
	X Walk 1 Slope (%)	2.3		X Walk 2 Slope (%)	N/A
	X Walk 1 X Slope (%)	1.1		X Walk 2 X Slope (%)	N/A

N/A	Ramp inside XWalk1?	N/A	N/A	Ramp inside XWalk2?	N/A
	Road Slope (%)	1.1		Clear Space?	N/A
	Road X Slope (%)	2.3	N/A	Clear Space to XWalk (in)	N/A
N/A	Any Obstructions?	N/A	N/A	Storm Grate/Utility Hazard?	N/A
	Obstruction Type			Storm Grate/Utility Type	
		N/A			N/A
			Yes	Surface Condition? (G/P)	Good
			N/A	Curb Slope (%)	3.1

Possible Solutions:

Remove & Replace Curb Ramp With Two New Directional Ramps or Equivalent.

R304.5.3
